Method Statement for the repairs at Curson Lodge, 47 St. Nicholas Street, Ipswich, Suffolk.

Number 47 St. Nicholas Street is a grade II\* listed building of the later 15<sup>th</sup> century. On 12<sup>th</sup> February 2013 a car crashed into the front entrance of the building and dislodged the carved corner post as well as badly damaging the pair of oak entrance doors.

Rick Lewis, Traditional Oak Carpentry Ltd. 22<sup>nd</sup> February 2013. Revised and updated 27<sup>th</sup> February 2013.

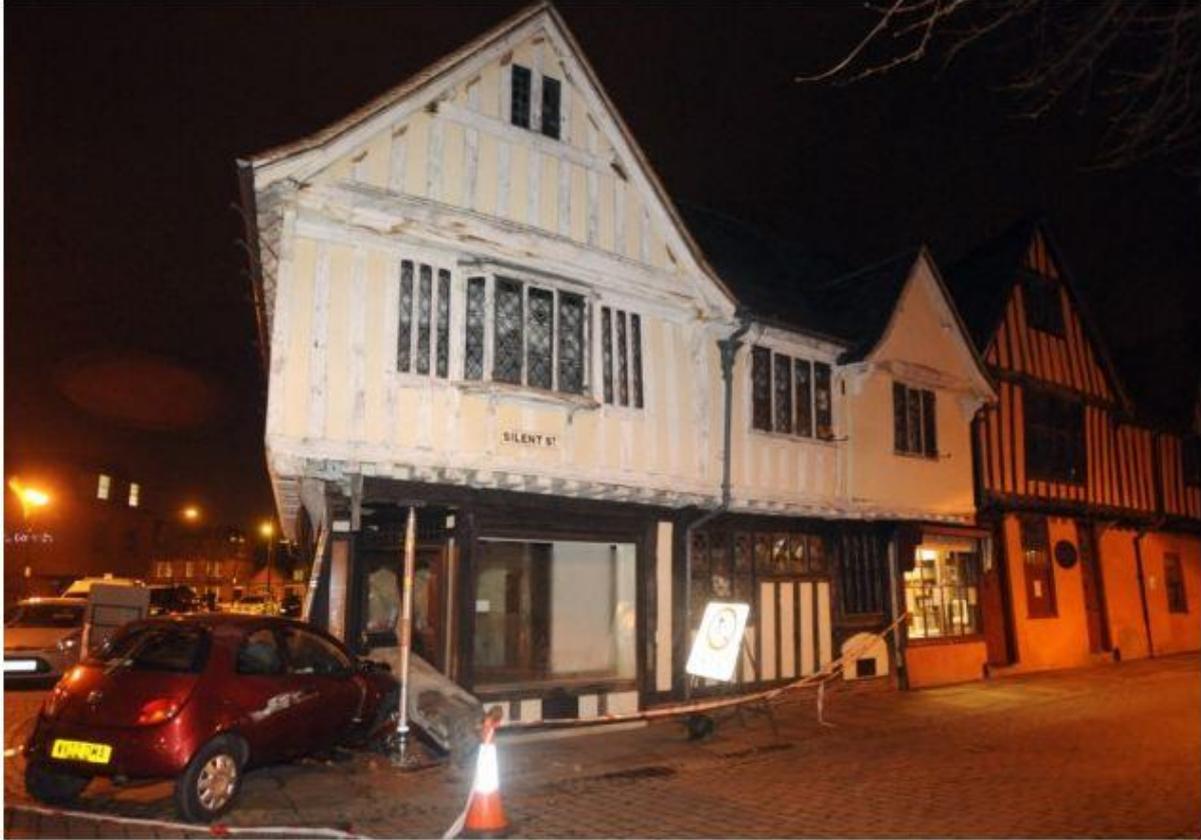
Immediately after the crash. East Anglian Daily Times photograph.

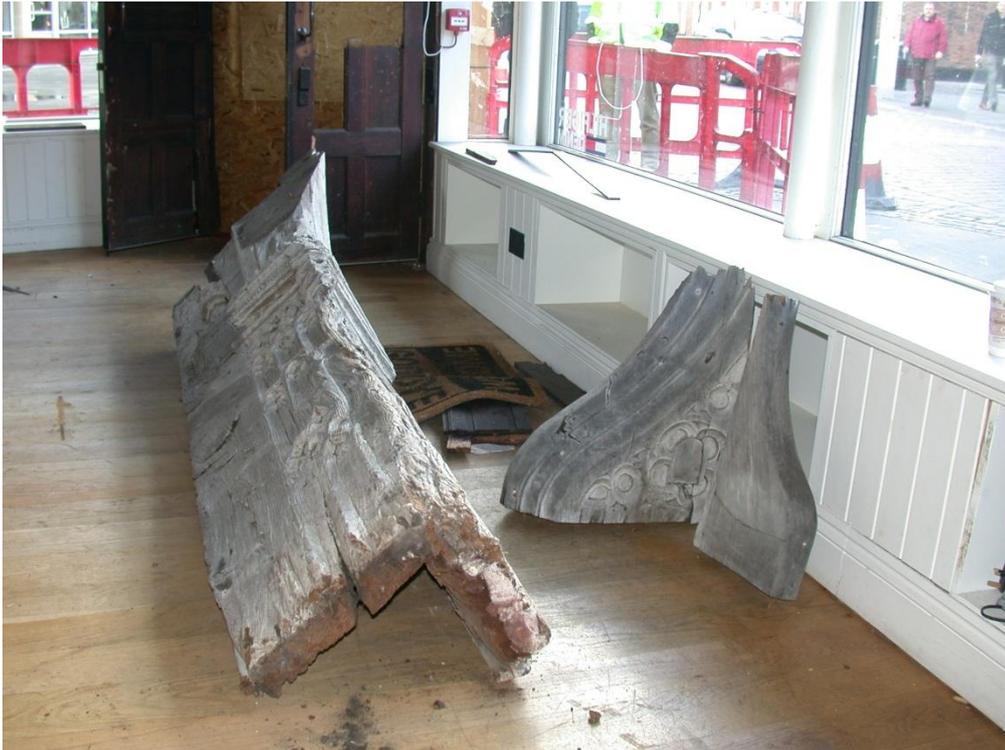
Despite the large size of the corner post, it was quite simply fixed into position; it had three short locating tenons and two skewed dowels that fixed it to the floor frame and jetty plates above. Underneath the bottom of the post was more recent brickwork with the brickwork also continuing up the inside of the post as in section it is actually "L" shaped (see pic. below). Hidden within the brick "infill" was a cast iron tubular strut of the same section as the two that still flank the doorway. It seems that the impact had sheared the strut and dislodged the whole assembly, this then being carried into the front doors along with the front of the car causing significant impact damage to them.

Inside the property a few days after the crash. The “L” section of the corner post can clearly be seen; to the right is a bracket and the 1902 (?) repaired section from the top of the post. In the background the damaged front doors still in-situ.

We will clean up the corner post and re-fix the 1902 repaired section back into position. There is another small patch that we will either re-cut or re-fix; all using two part epoxy glue for adhesive. This will be done off site in our workshop and once the post is repaired and we have the dragon beam supported we will bring the post back to site for reassembly.

The post was simply located into position with simple, unpegged tenons. Our intention is not to change this arrangement but if it proves unsatisfactory we will consider simple and hidden mechanical fixings for a more positive location.

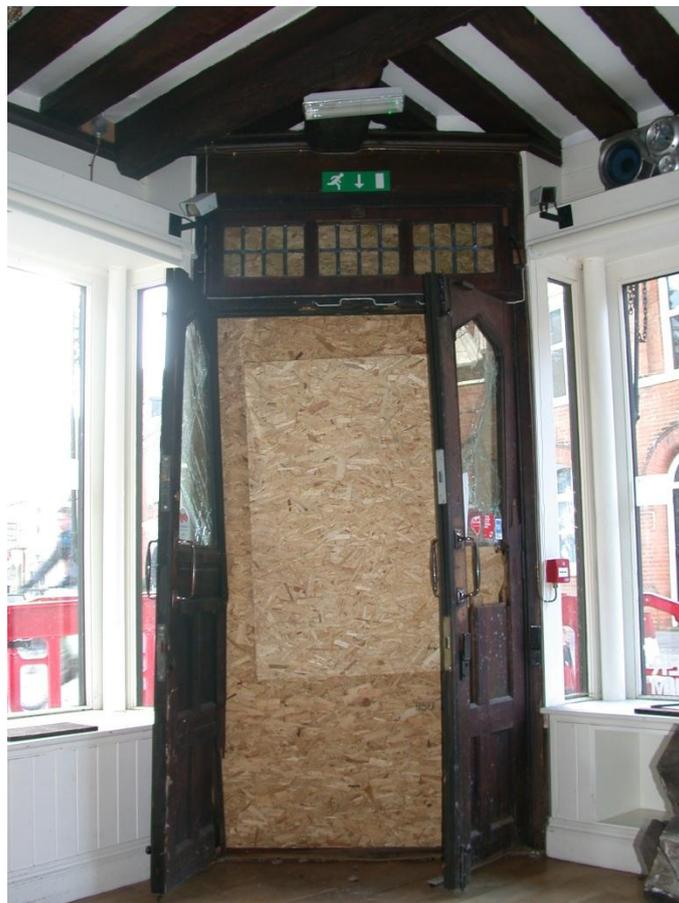
The damaged front doors. Remarkably the door frame itself has survived intact as have the two adjacent cast iron struts.

The doors are to be removed from site and a joiner will copy them exactly. Any components that can be saved and reused will be incorporated into them for maximum retention of fabric irrespective of antiquity. Once re-hung we will stain them to try and blend them with the existing framing.

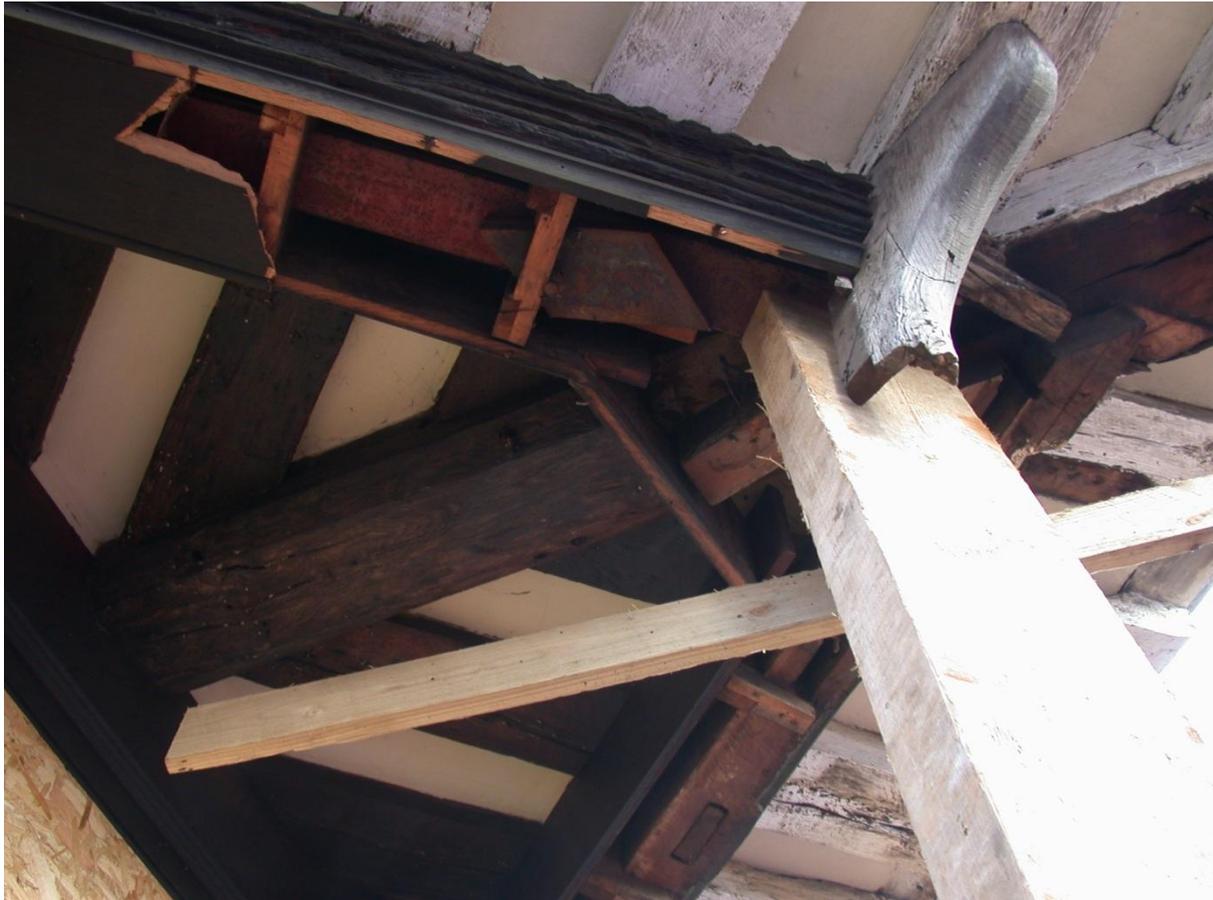
Looking up at the floor frame. Running diagonally is the dragon beam, a large sectioned primary joist that has smaller sectioned common joists tenoned into it. The irregular shape of the Burgage plot can be clearly seen from the angles of each elevation. The original jetty plate can be seen on the right (Silent Street elevation) whereas the St. Nicholas Street jetty plate has been replaced by a steel beam and both elevations then boxed in with thin oak planking. One of the two brackets is still in position but further investigation seems to suggest that they are not original to the building as they are fixed into position with relatively modern nails. This is odd as the corner post has joinery for a pair of brackets so perhaps this post came from elsewhere?
