Anonymous Farmhouse, Middle-of-Nowhere, Suffolk.

A condition report on the historic carpentry.

I visited the property on 26th February 2013 to assess the condition of the historic timberwork prior to potential purchase.

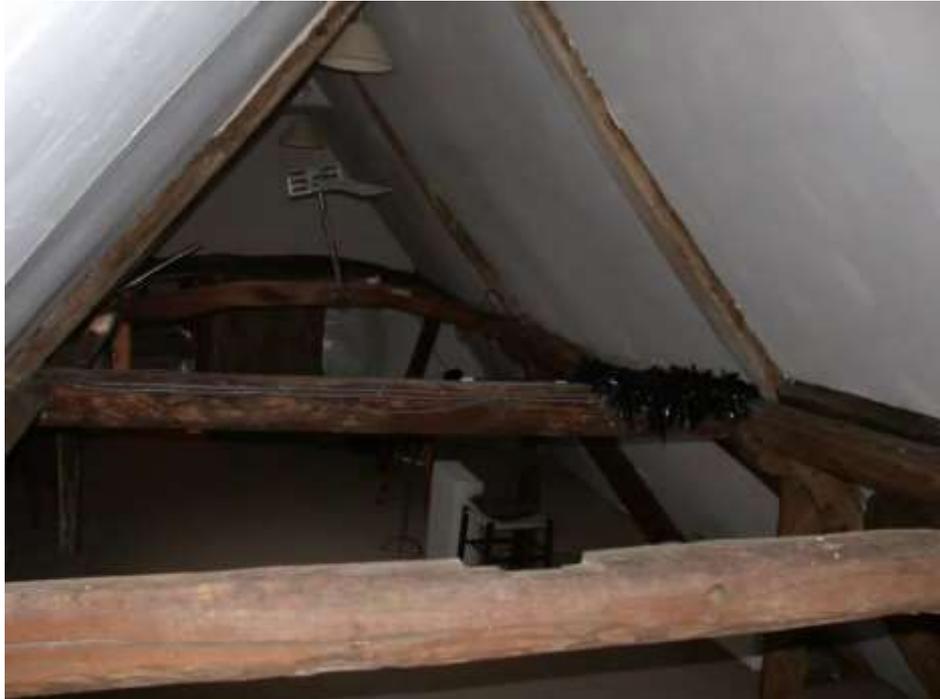
Fig. 2 above: The clasped purlin roof looking north.

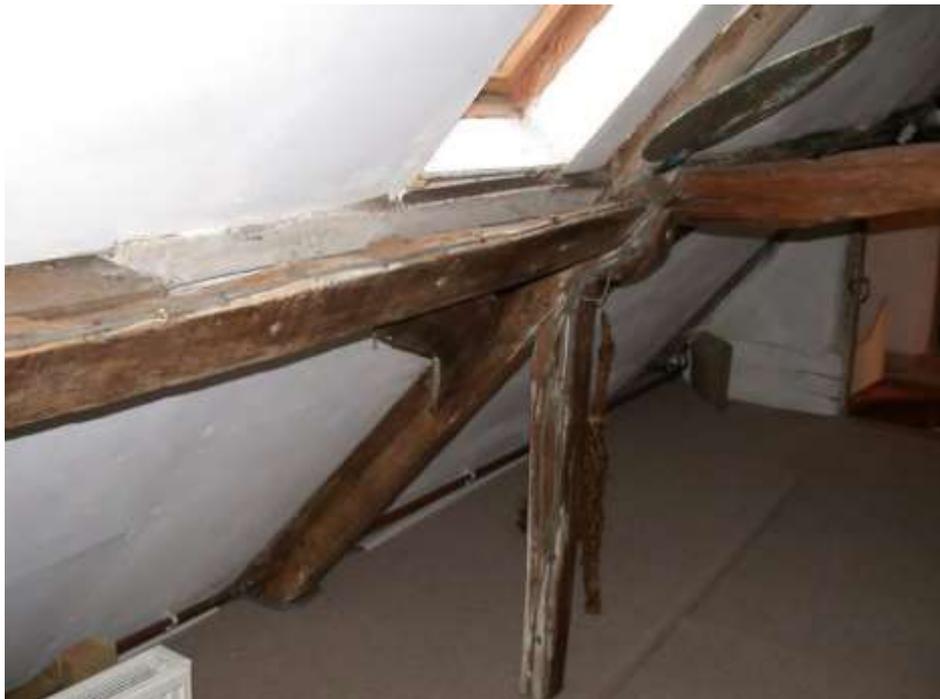
Fig. 3 below: Purlin runs with extra timbers packed behind to create a better alignment. Note also that the collar has been cut close to the rafters for easier access within the space.

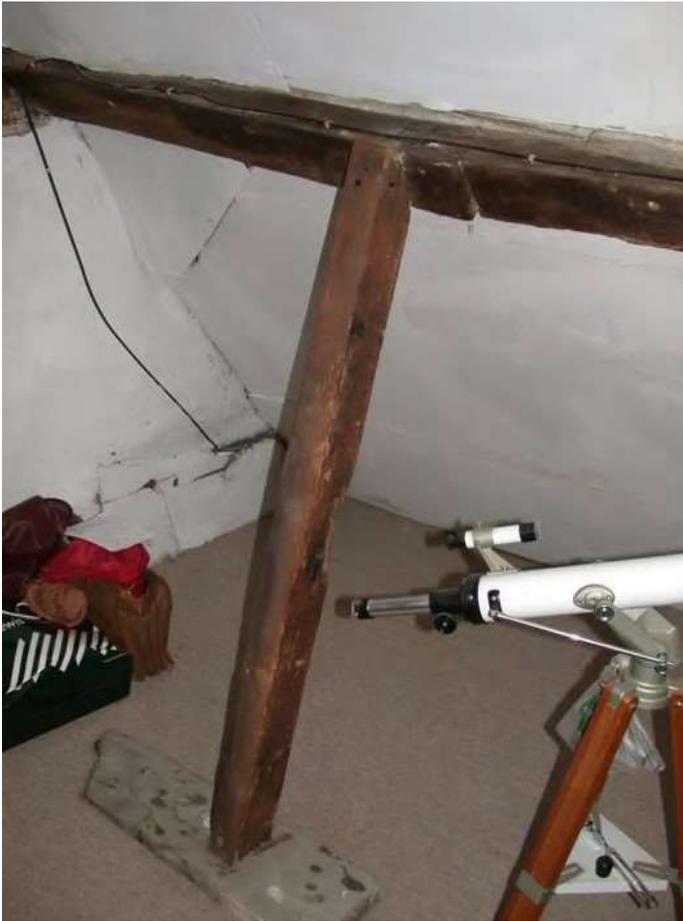
Fig. 4 left: An additional strut has been fitted below the western purlin scarf to assist against deflection.

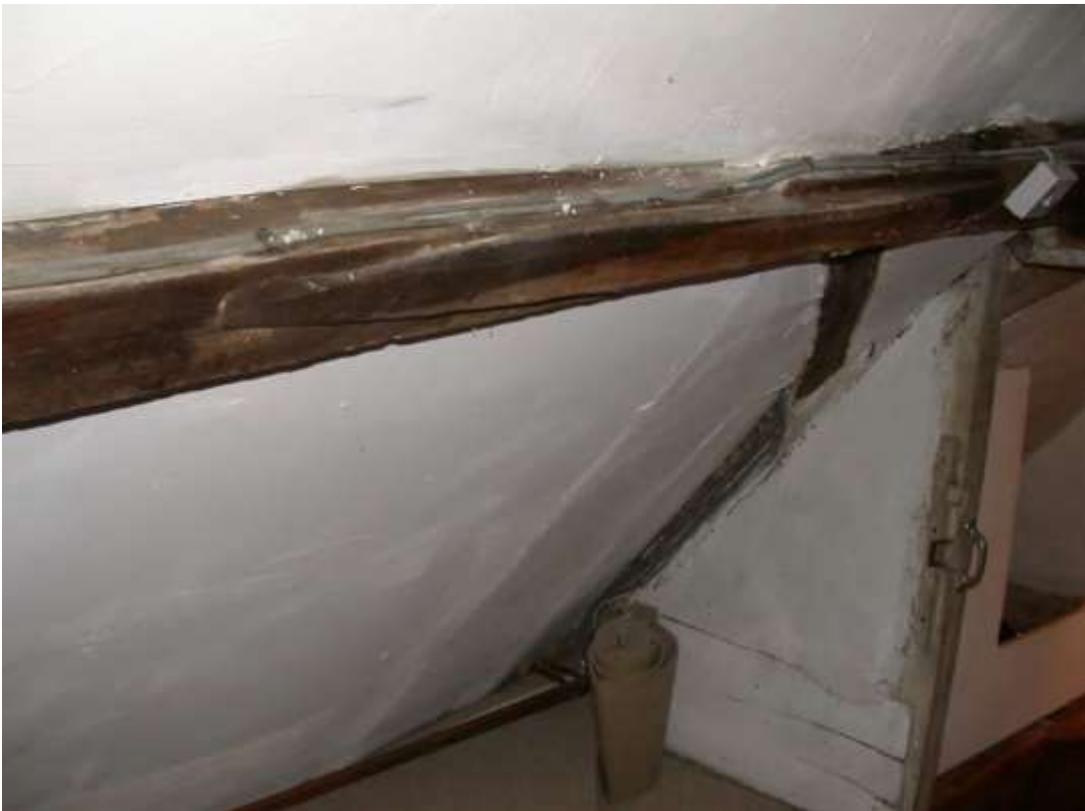
Fig. 5 below left: The eastern purlin scarf has a simple timber splint attached to assist against deflection. It has been fixed in place with hand-forged nails so I can only assume it has been in this position for some time without any major deflection. A strut would restrict access at this position given that the attic appears to have been used for accommodation since at least the early 20th century but probably before that time.

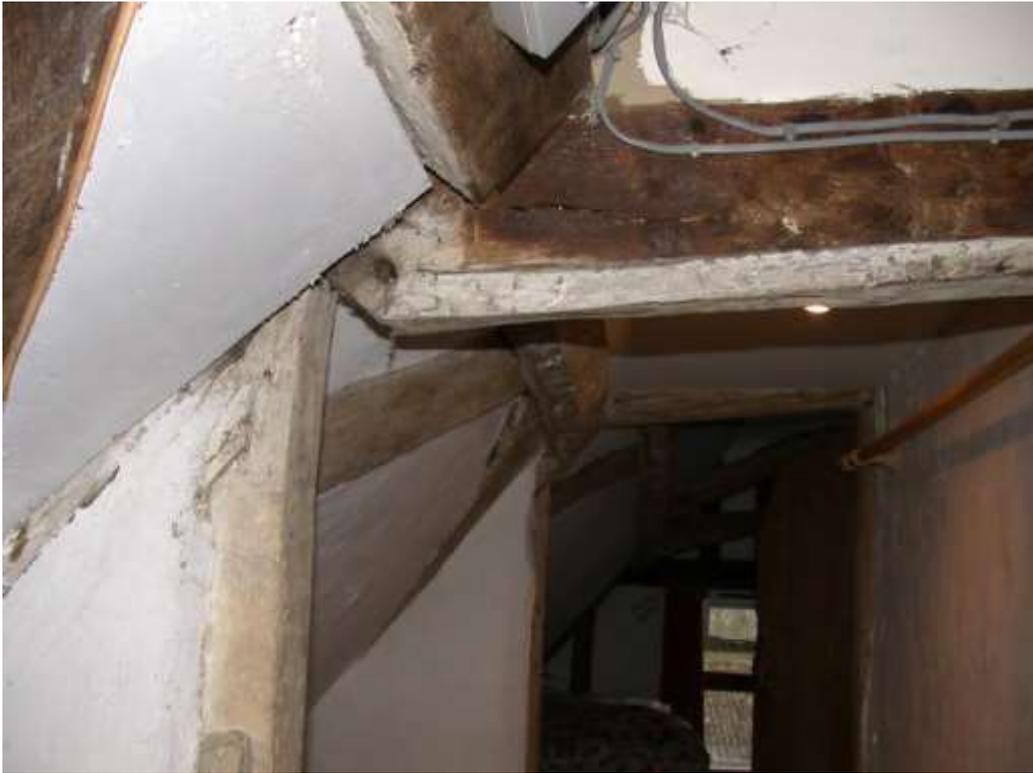
Fig. 6 above: One of the collars has detached from its mortise into the principal rafter. This appears to have been in such a position for at least twenty years when the plasterboard was cut around it.

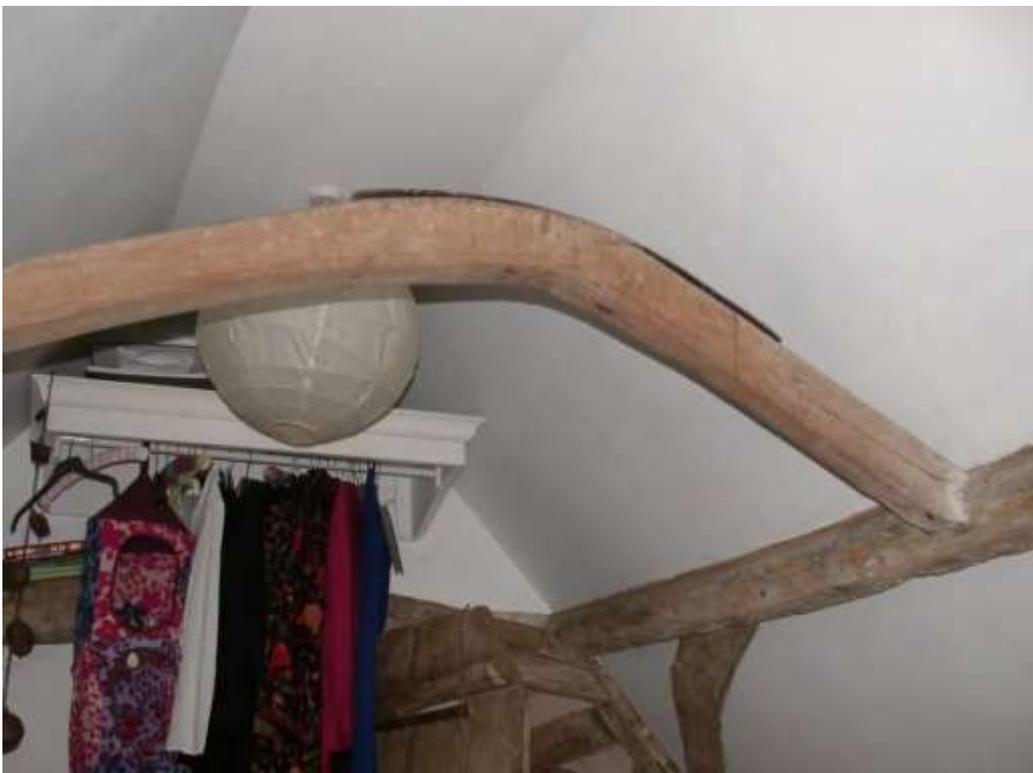
Fig. 7 below: A truly vernacular collar has been retro-fitted for ease of access within this southern bay of the roof. It has been splinted above with a section of hand-forged iron wagon tyre for extra strength.

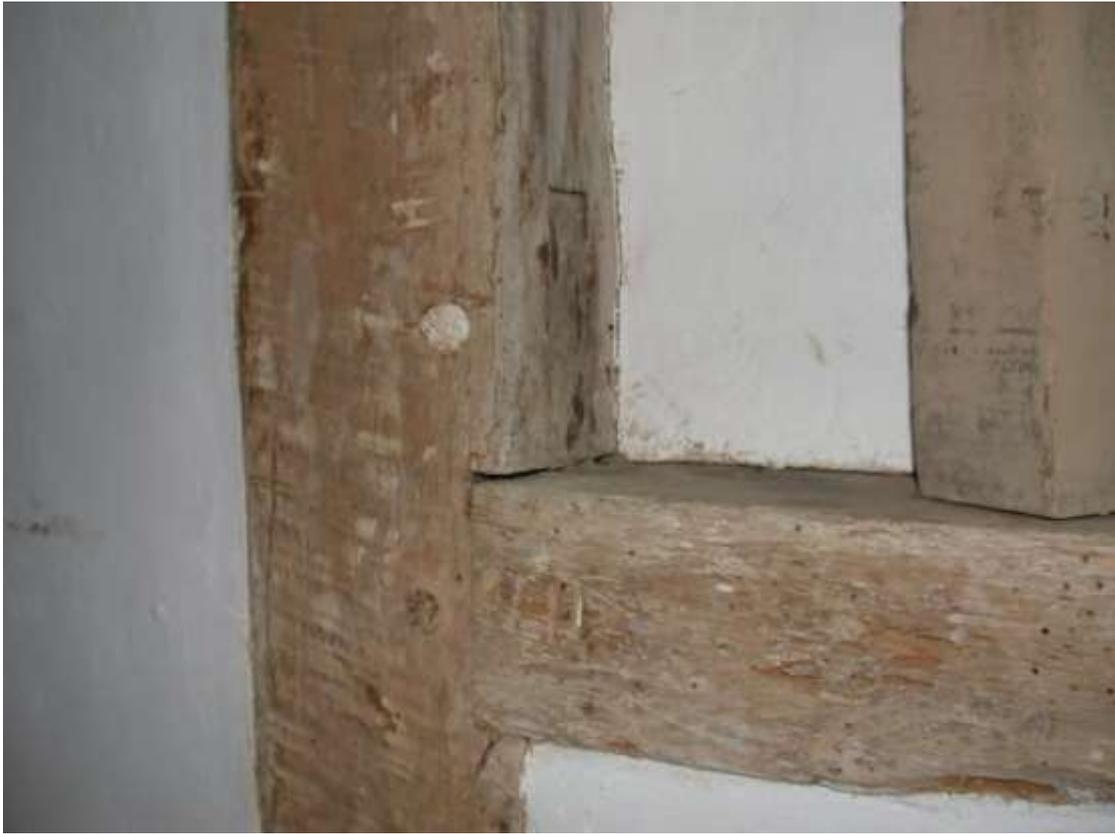
Fig. 10 above: The mullioned window sill has been lowered from its original position and the void mortise filled with a patch. This could have been a mistake or it could have been a change of mind by the original client. Equally it could have been a slightly later alteration but I suspect it was a change of detailing with a larger projection for the sill requiring it to be housed *into* the edge of the stud. The carpenters number // can also be seen.

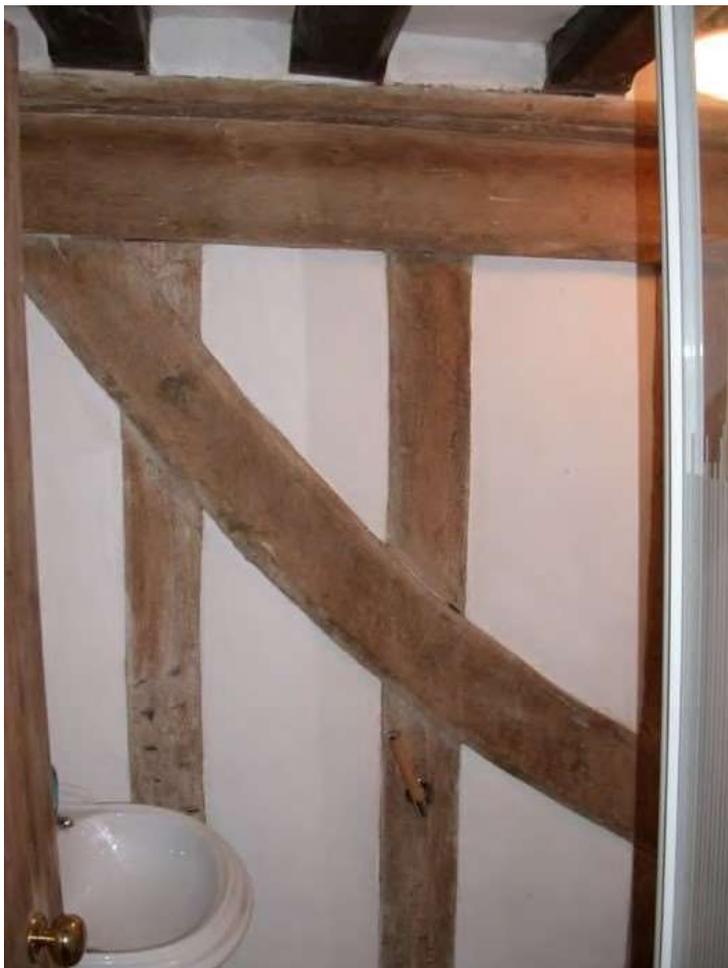
Fig. 11 left: Exposed framing within the en-suite to bedroom 4. The timbering is in excellent condition.

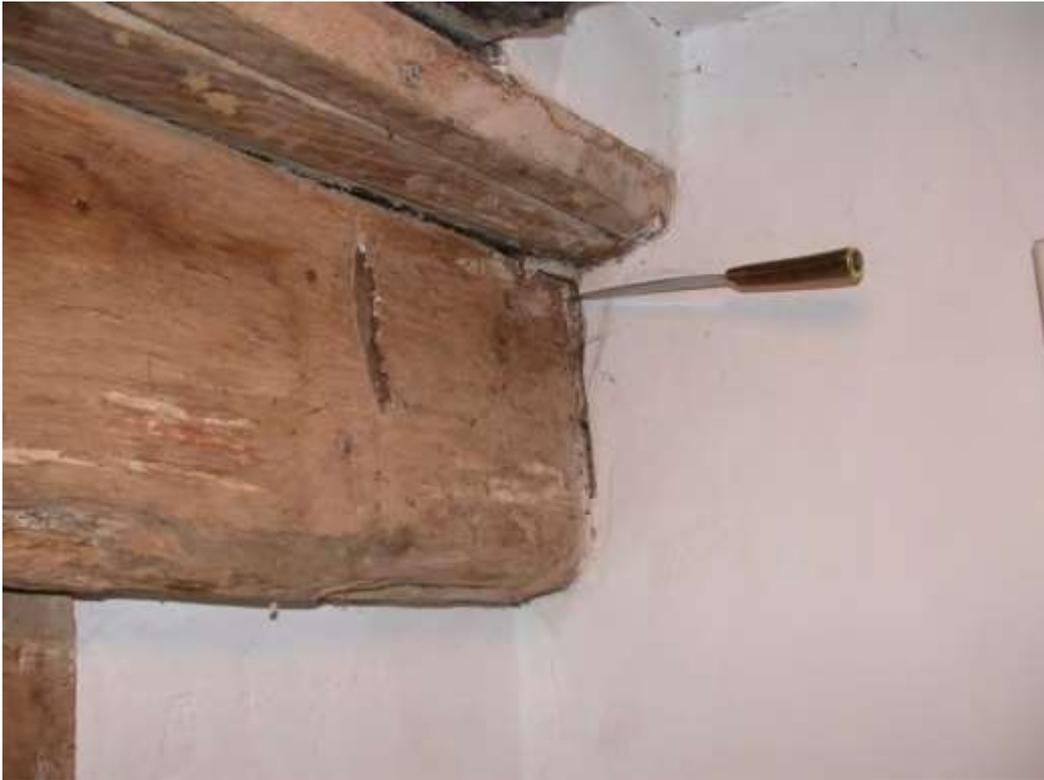
Fig. 12 above: The eastern wall plate where it meets the south gable. Despite some evidence of insect decay the timber seems sound. The attic joists have drifted towards the edge of the plate in antiquity but this has been addressed (twice!) by nailing a simple ledge into place.

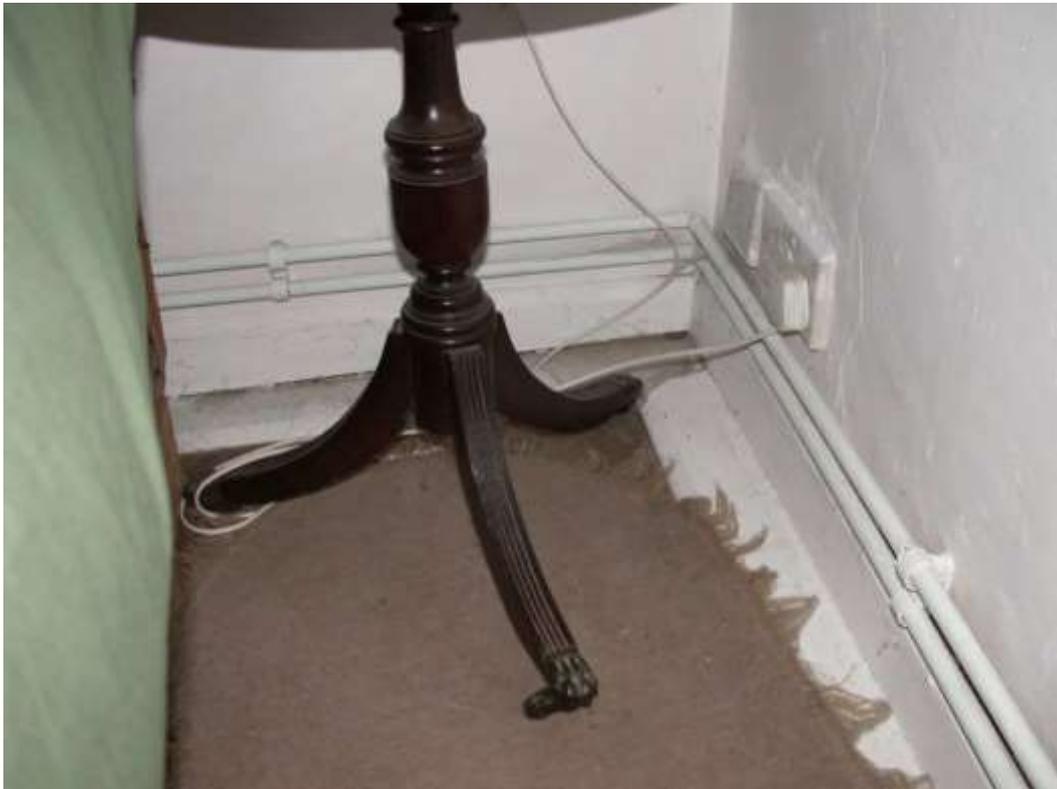
Fig. 13 below: Within bedroom 4 the floors are made up of wide oak boards but the edges have a simple painted softwood beading which suggests a small gap due to drift or decay.

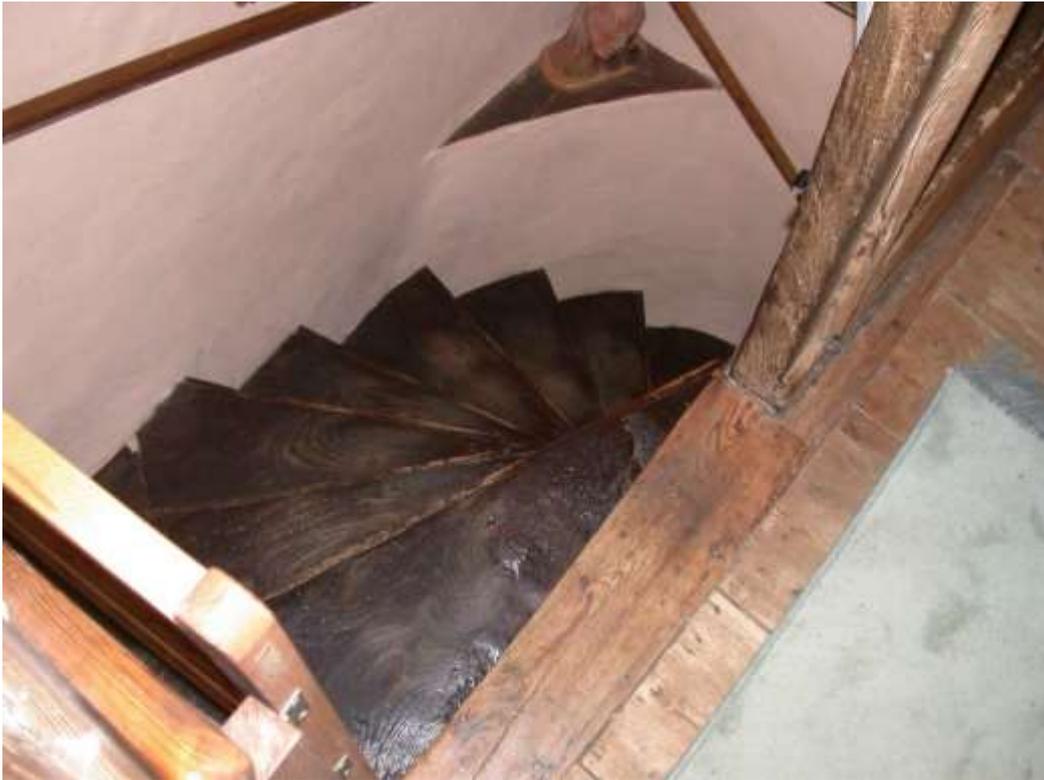
Fig. 14 above: The 17th century staircase. The list description suggests that the attic flight is original but it is clear they have actually been altered and repaired over time. This also goes for the first floor to ground floor stairs but they seem no more or less “original” and certainly contain much early fabric that is built into place suggesting little has changed.

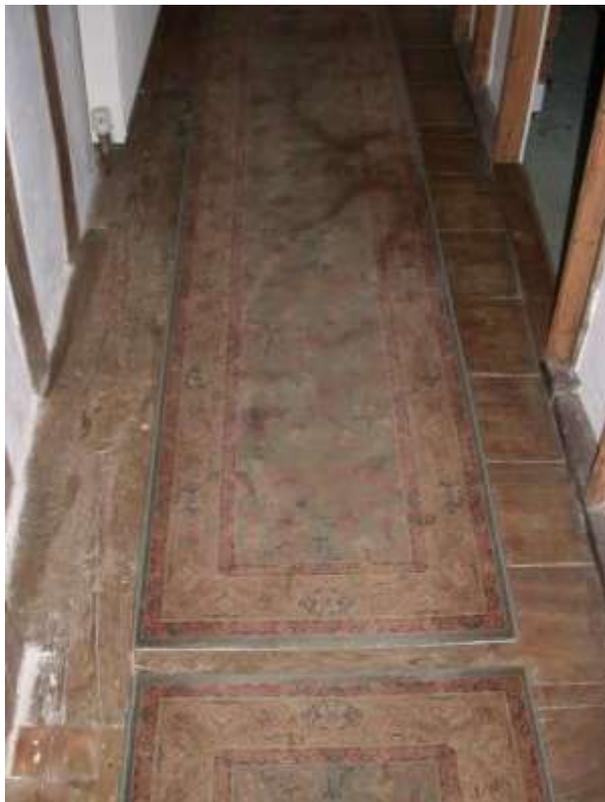
Fig. 17 left: The east wall is to the left, the corridor partition to the right. The floor boards at right sit on the floor frame, running perpendicular to the joists. To the left there are floor boards running lengthways suggesting some infilling of damage or drift. This quite probably dates from the 19th century period of alteration and should be of no major concern.

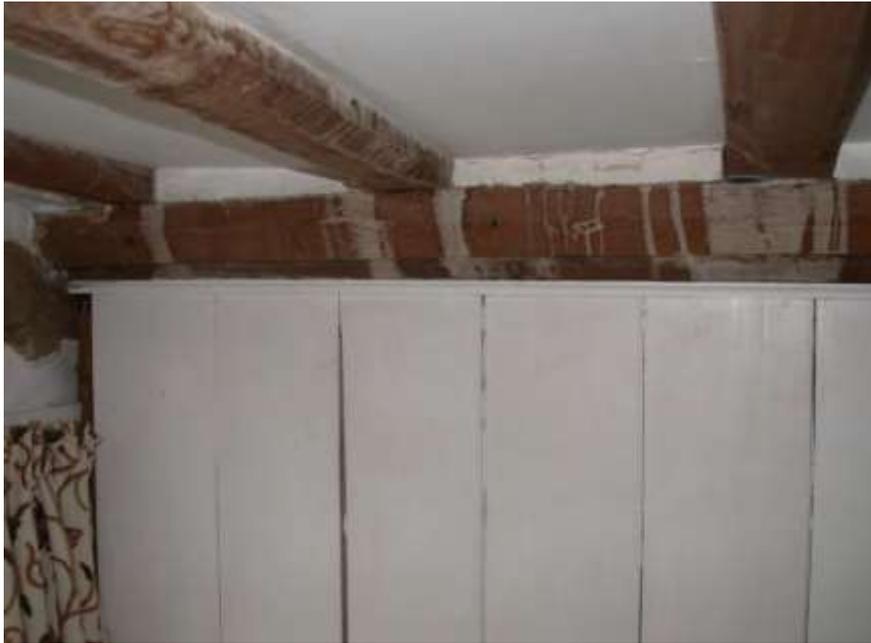
Fig. 18 above: There has been some recent water ingress within bedroom 3. The source of this needs to be checked and assessed to ensure that any repairs were done well enough to prevent recurrence.

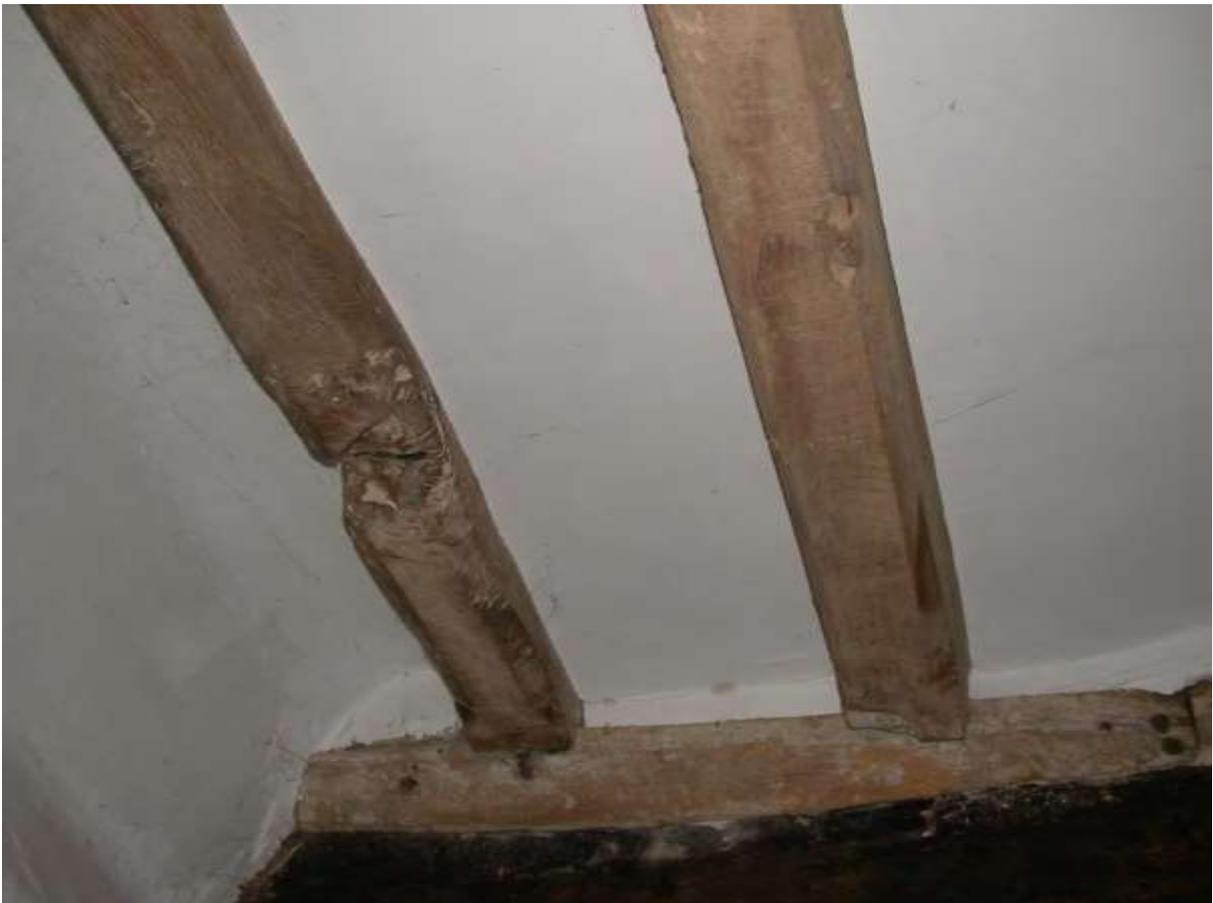
Fig. 19 below: A floor joist within bedroom 1 is of very poor section but I highlight it purely for interest. As it has been installed at the very edge of the floor frame it has basically taken no major load in its lifetime and thus it has performed adequately despite its obvious poor quality.

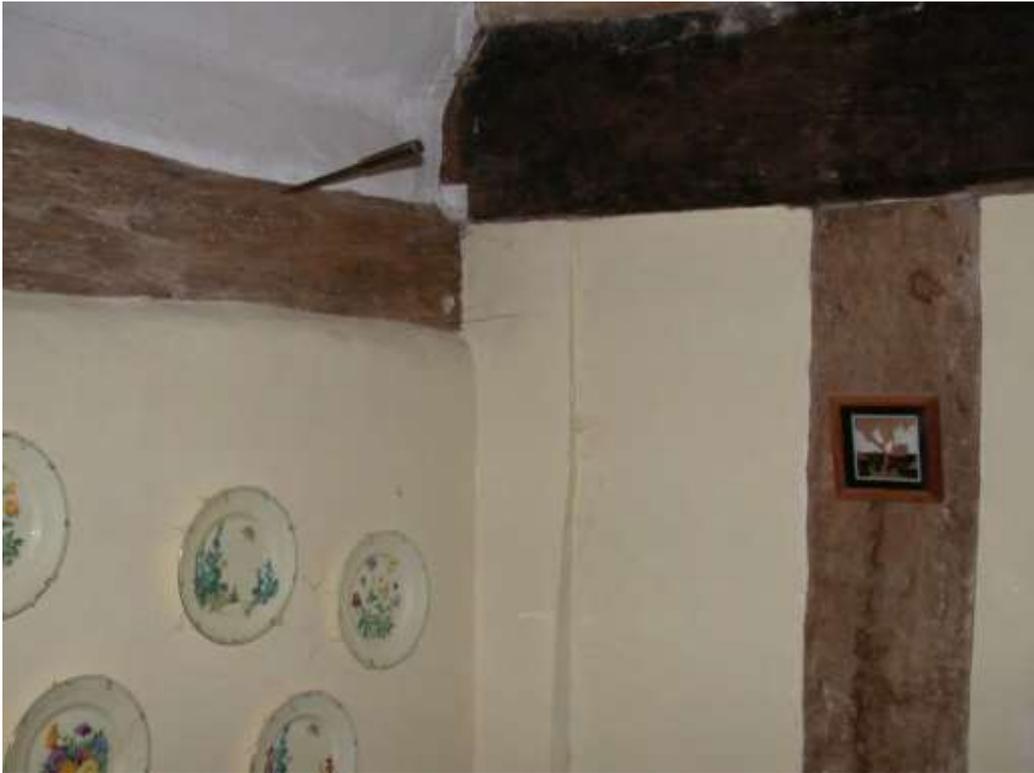
Fig. 20 above: The north-west corner between wall plate and tie beam. The wall plate has lowered in relation to the tie beam but given the 19th century plaster surfaces all around these timbers I would suggest that the drift predates that period, possibly by a long time. The north end of the wall plate has some insect damage but once again it is pretty firm to probing.

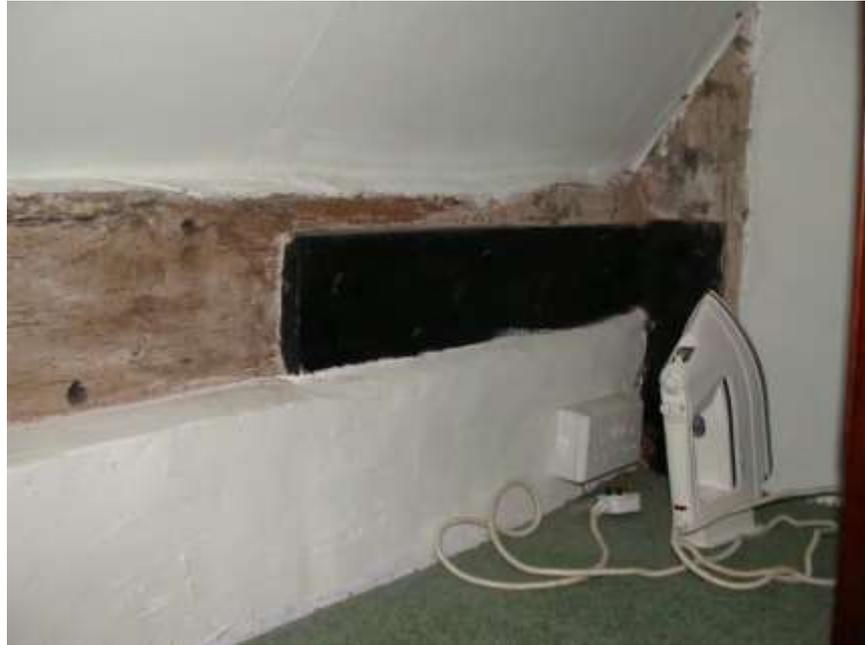
Fig. 22 above: the service wing has a steel bracket fixed between the end of the wall plate and the wall frame of the main house. It also has steel plating of similar provenance within the bathroom space (Fig. 23 below). I can ascertain no dire need for these and can only suggest they have been fitted by someone more cautious! Within the bathroom are over the wall plate scarfs (see later image) but from outside they seem superfluous.

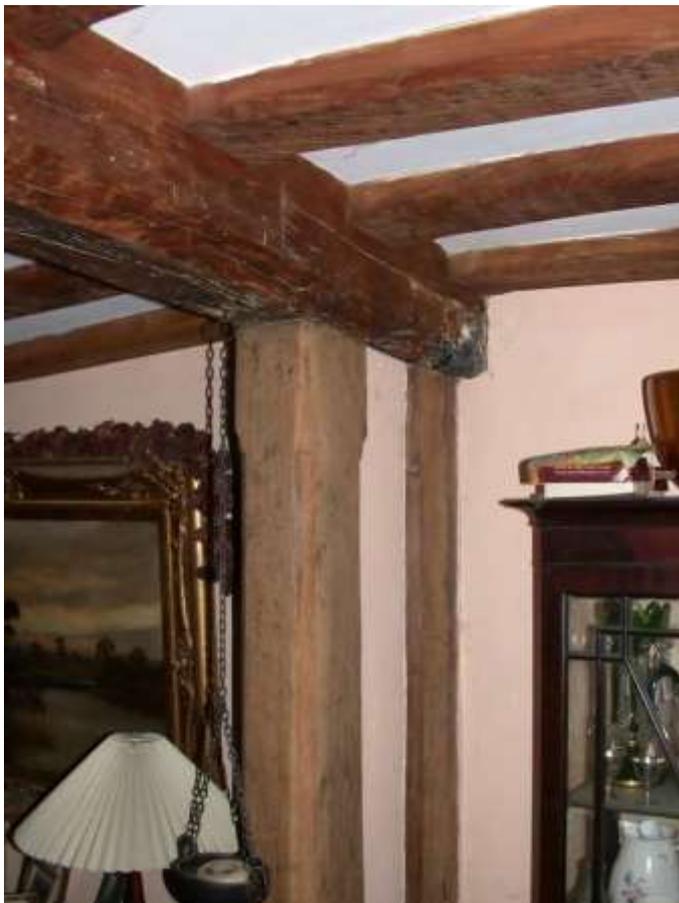
Fig. 25 left: At the southern gable end the spine beam has two extra supporting posts. Neither of these is original and they suggest that either the spine has problems or that the gable framing behind the plaster gives no support. I noted no problems with the actual spine beam so I can only suggest that the gable gives no support to the floor frame.

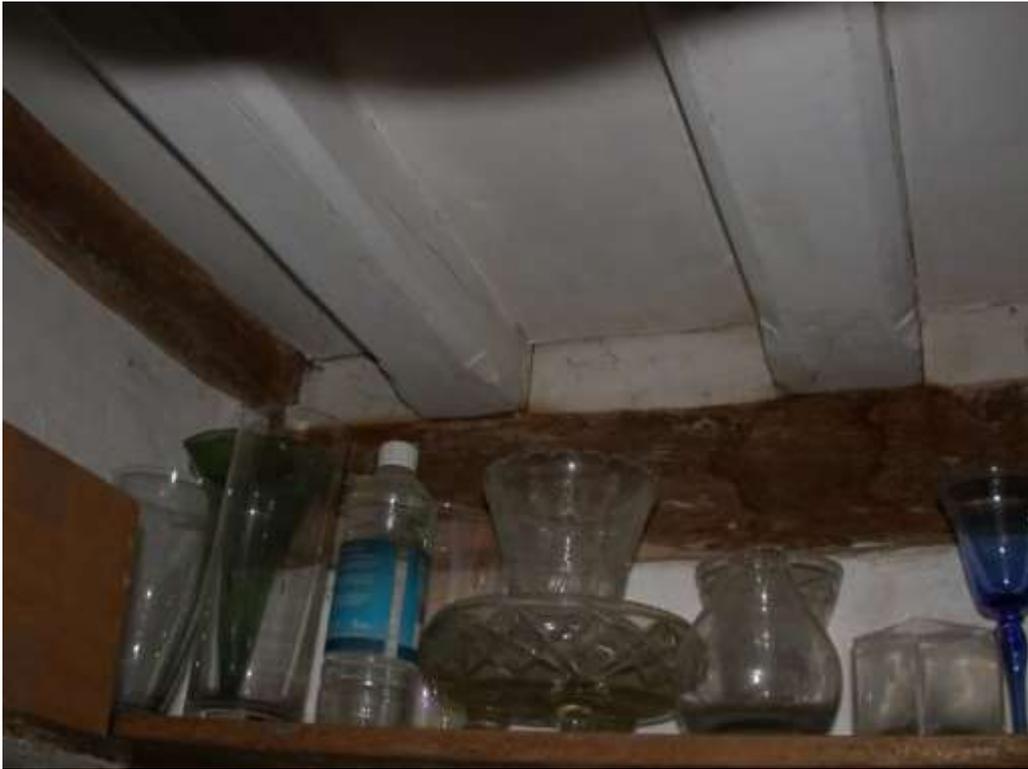
Fig. 41 above: There is evidence of water ingress at first floor level on the north gable. There may have been problems where the lean-to roof abuts the earlier gable and the flashings should be checked for effectiveness.

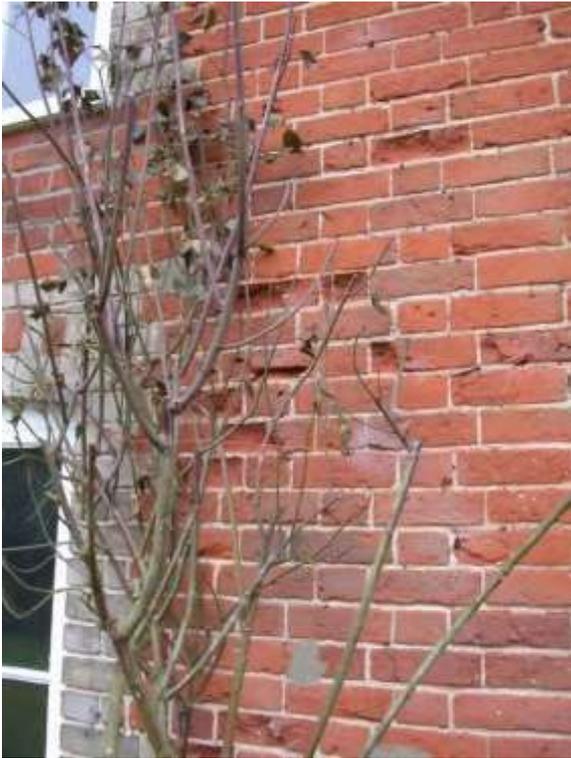
Fig. 45 left: Spalling to the brickwork on the western elevation. This is likely to have been caused over time by higher moisture levels brought on by the adjacent planting. Some small sections have been repointed with strong cement mortar and this should not be repeated as it will merely accelerate the recession of the softer bricks. Only soft lime based mortars should be used if any repointing is deemed necessary.

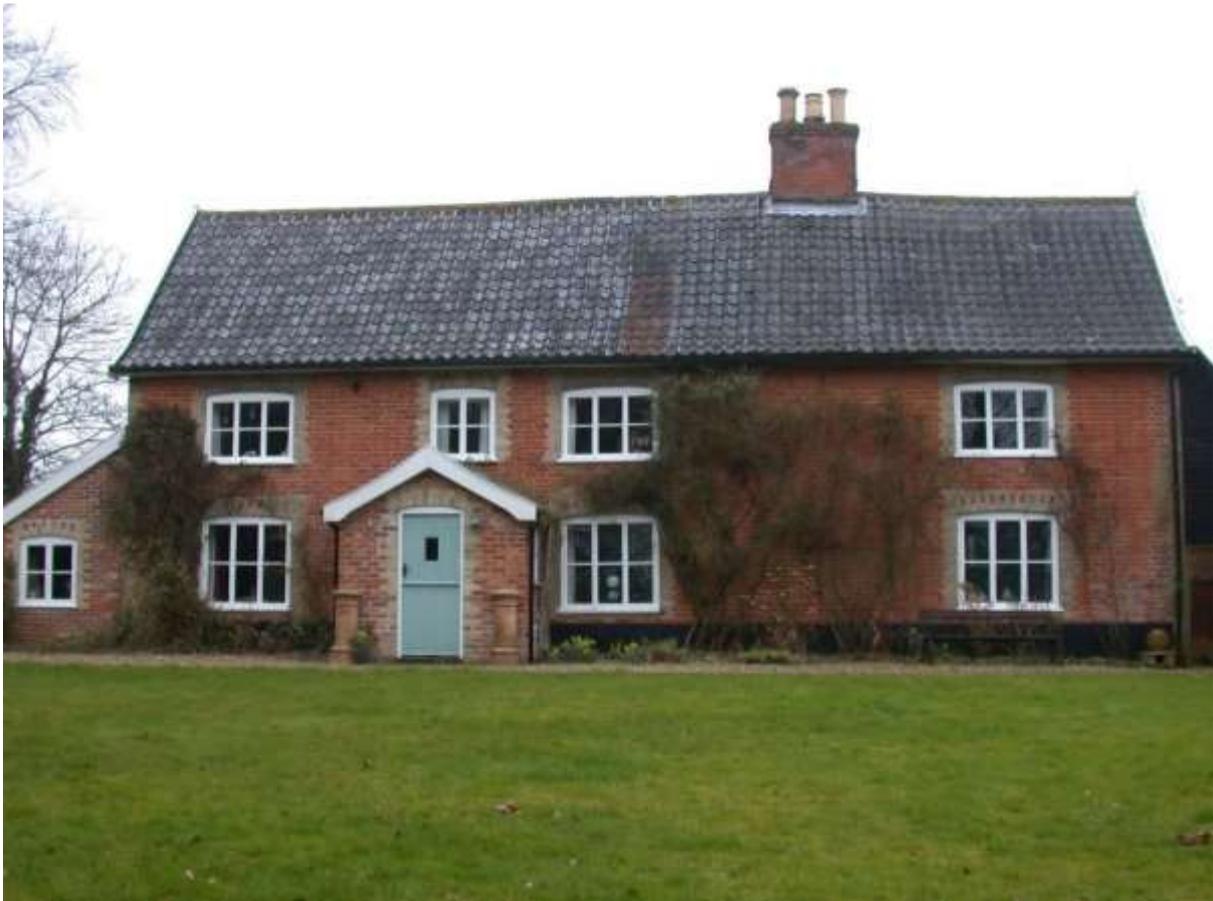
Fig. 46 below: Anonymous Farmhouse from the west. Note the area of different tiles in the lower centre of the roof. It would be worth trying to ascertain why this was done and when. Any issues can then be reviewed for effectiveness.

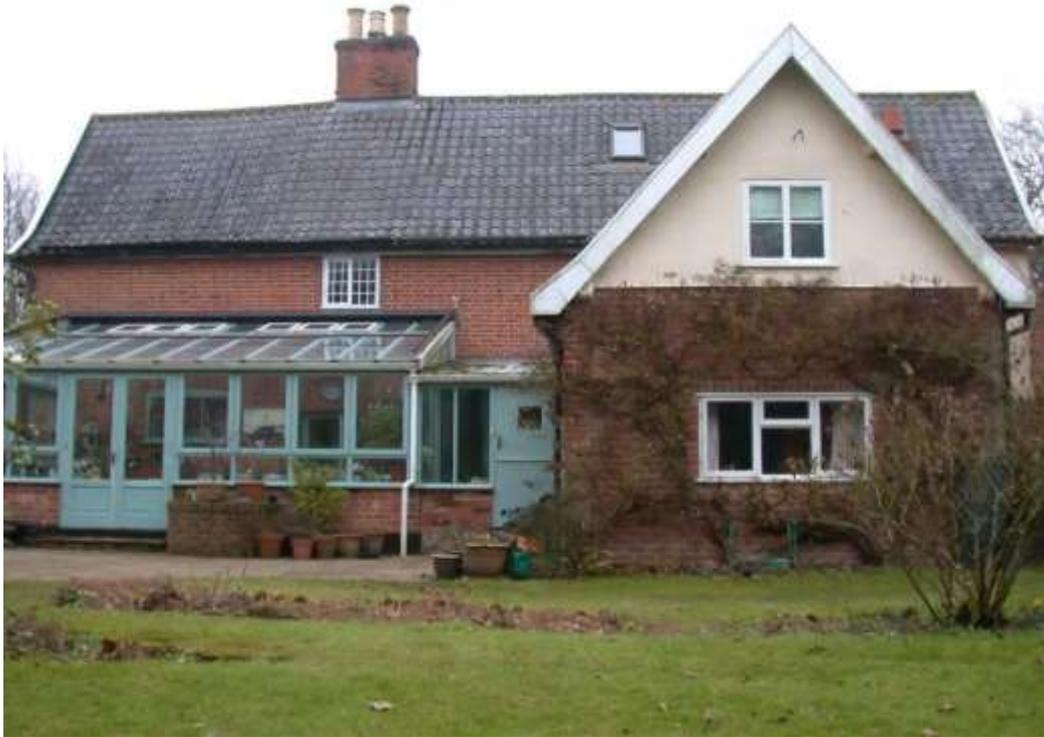
Fig. 47 above: Anonymous Farmhouse from the east. The relatively modern conservatory is a little tired in places and was not examined in any detail by us. It could easily be repaired and redecorated to give another decade or more of use.

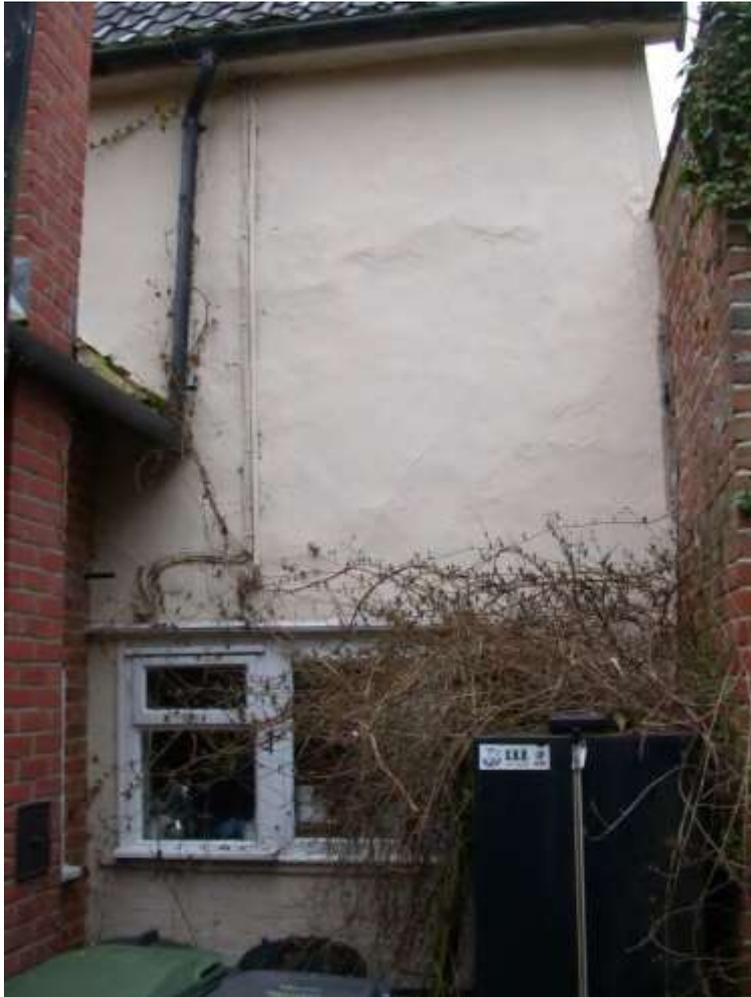
Fig. 49 left: Cracked and filled render to the northern end of the eastern wall. This section has no brick façade as it was hidden from public view around the back. It seems to be mostly lime render but has been filled where it has cracked over time. This section could be raked out, filled with lime and redecorated for relatively little money.

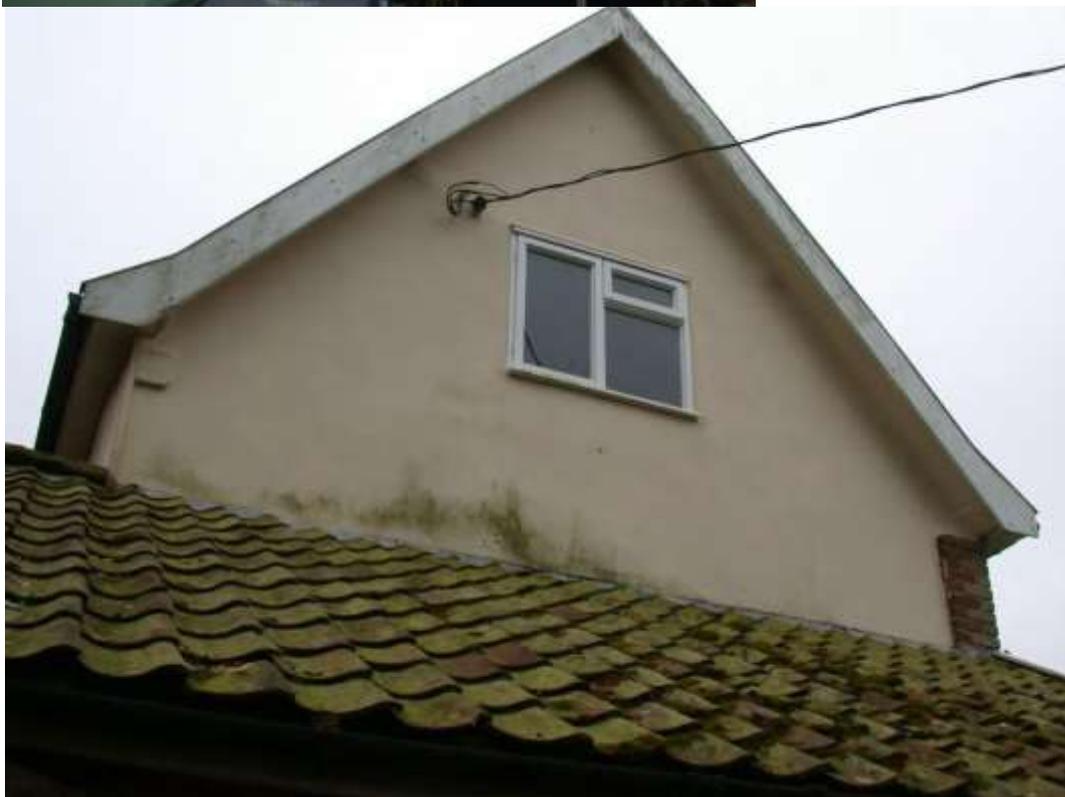
Fig. 50 below: The northern gable *seems* to have a cement based render above the newer lean-to roof that covers the library. Some water ingress was evident below so this section should be checked for effectiveness although of course the water stains could pre-date the current render and flashings.

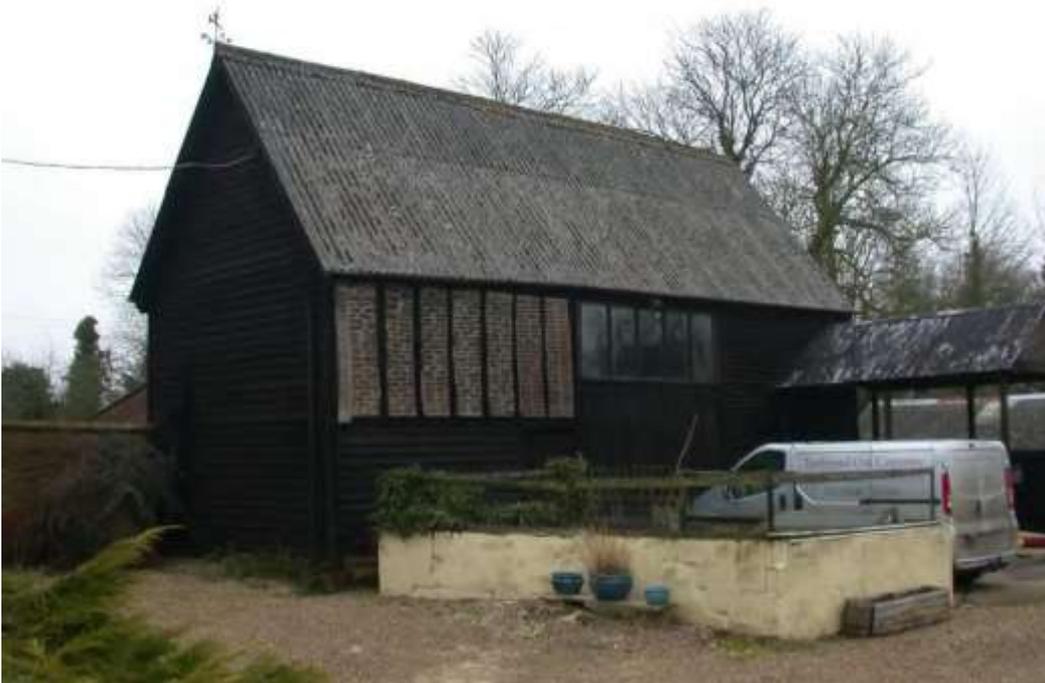
Fig. 51 above: The barn from the south west. The brick infill is relatively modern and over time will allow water ingress. It would be wise to eventually consider removing it and re-boarding or rendering this section.

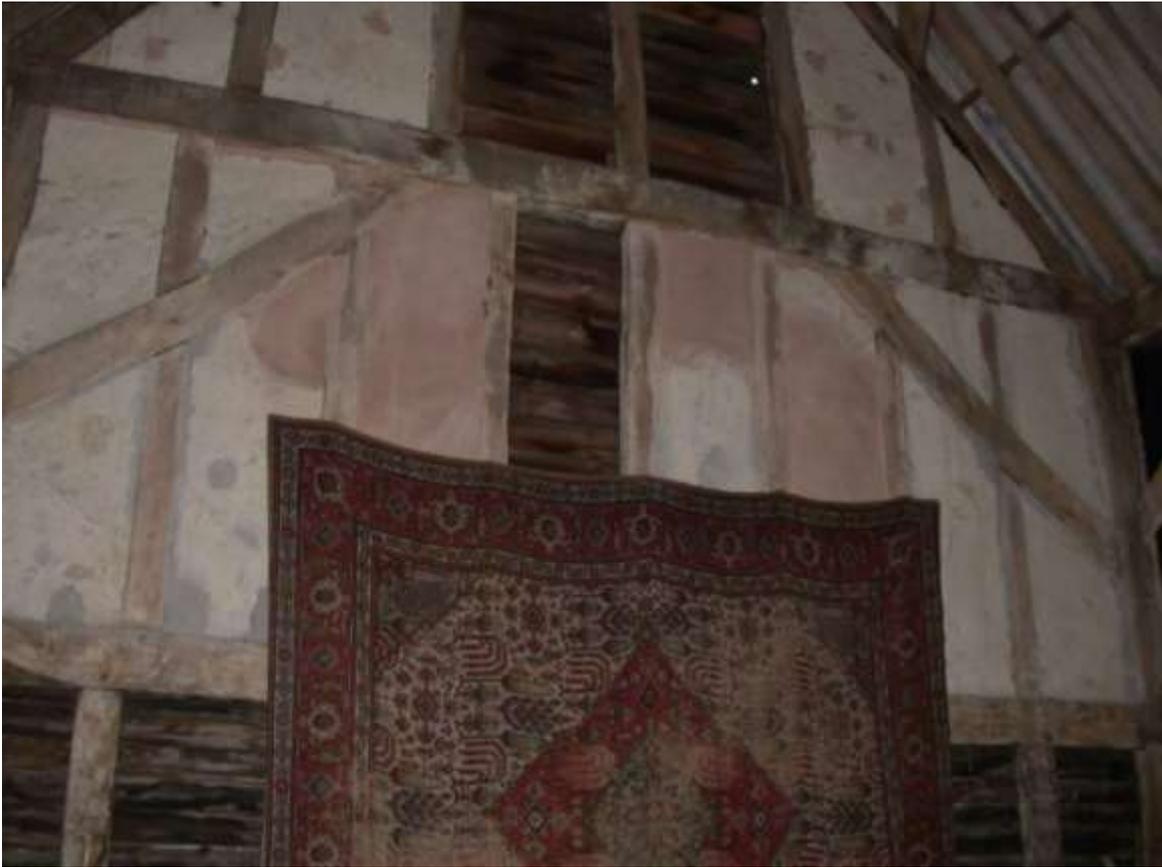
Fig. 55 above: The eastern gable of the barn frame from inside. The historic infill panels (wattle and daub) have been patch repaired with a pink gypsum plaster; this isn't ideal but it has at least helped keep the panels in place. In time it would be good to rake the gypsum out and repair with clay daub with a chalk based plaster skim.

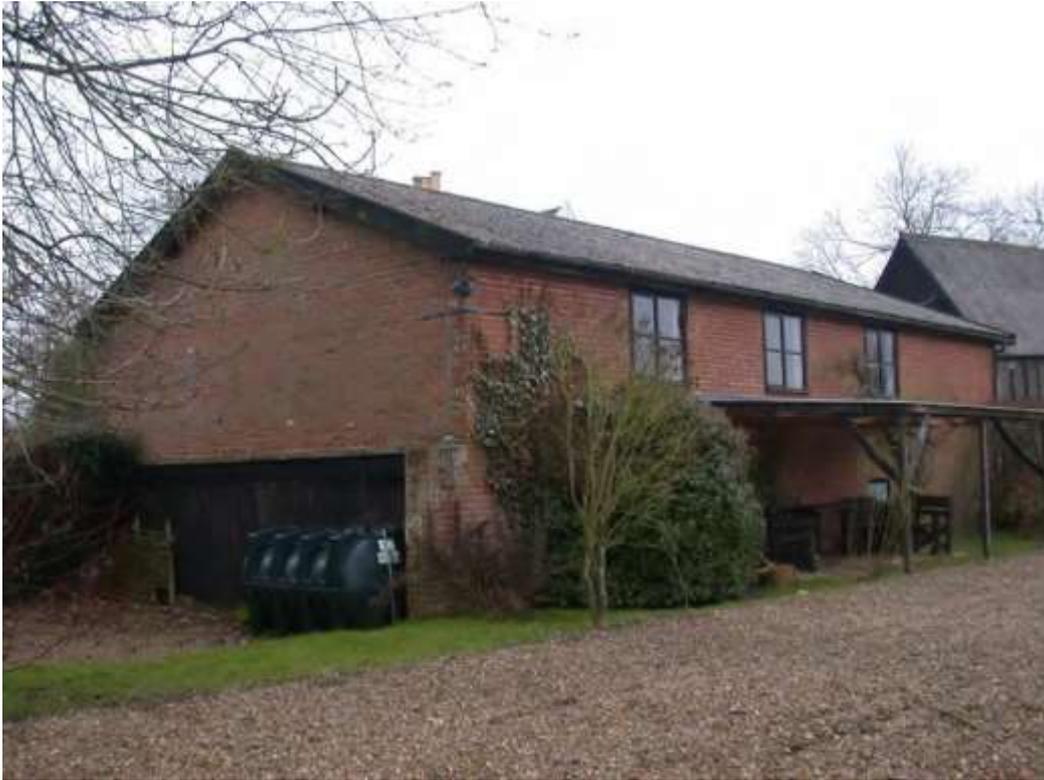
Fig. 57 above: The maltings from the south west. Some areas of the brickwork, particularly this gable end, have been patched with cementitious mortar but essentially it is in good order externally.

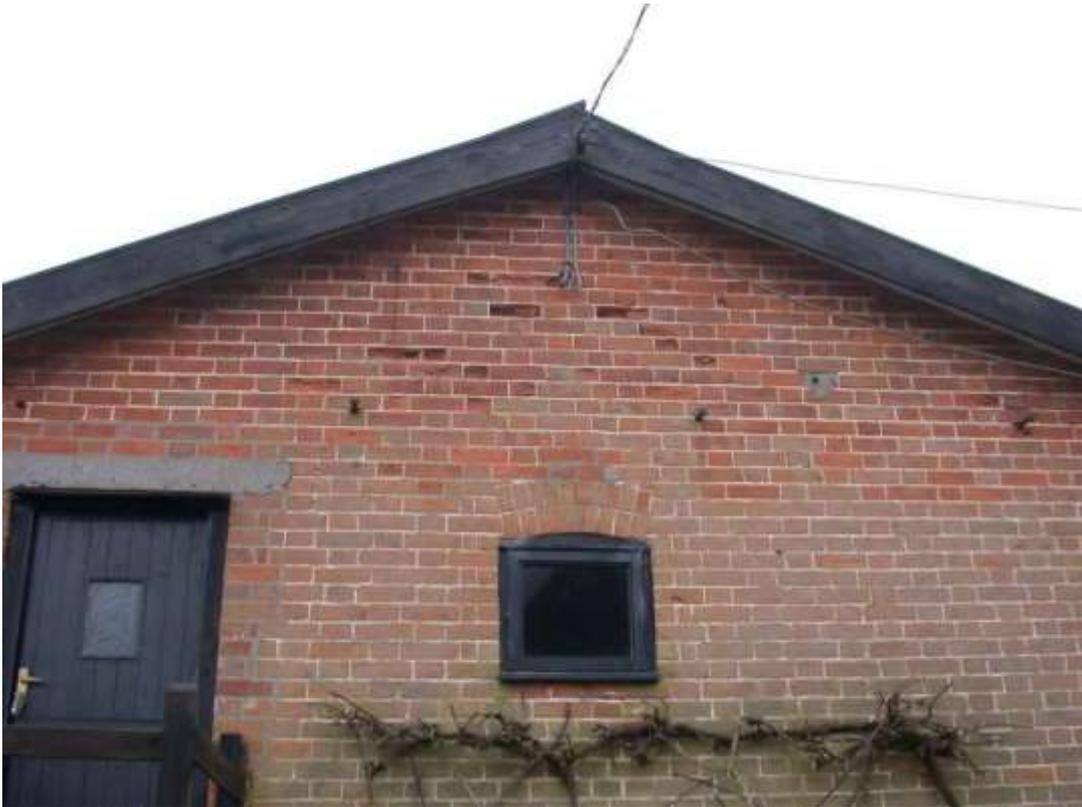
Fig. 59 above: The east gable has some spalling to the brickwork as well as evidence of mason bees.
