Anonymous Farmhouse, Middle-of-Nowhere, Suffolk.

A condition report on the historic carpentry.

I visited the property on 26th February 2013 to assess the condition of the historic timberwork prior to potential purchase.

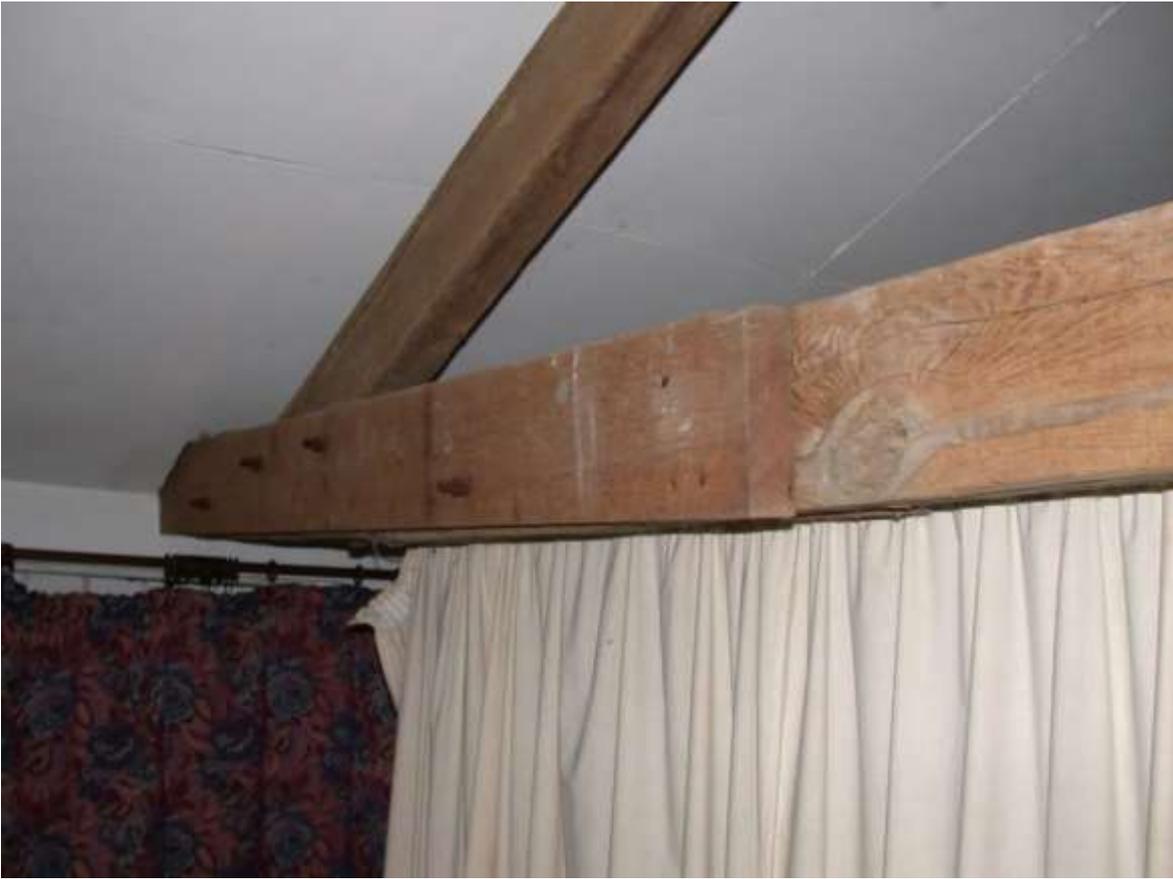
Fig. 63 above: One of the trusses has splints attached, presumably there is a problem with the tie beam underneath them but I could not see what this might be. The splints appear to have been there some time so my *guess* is that they are doing their job adequately.

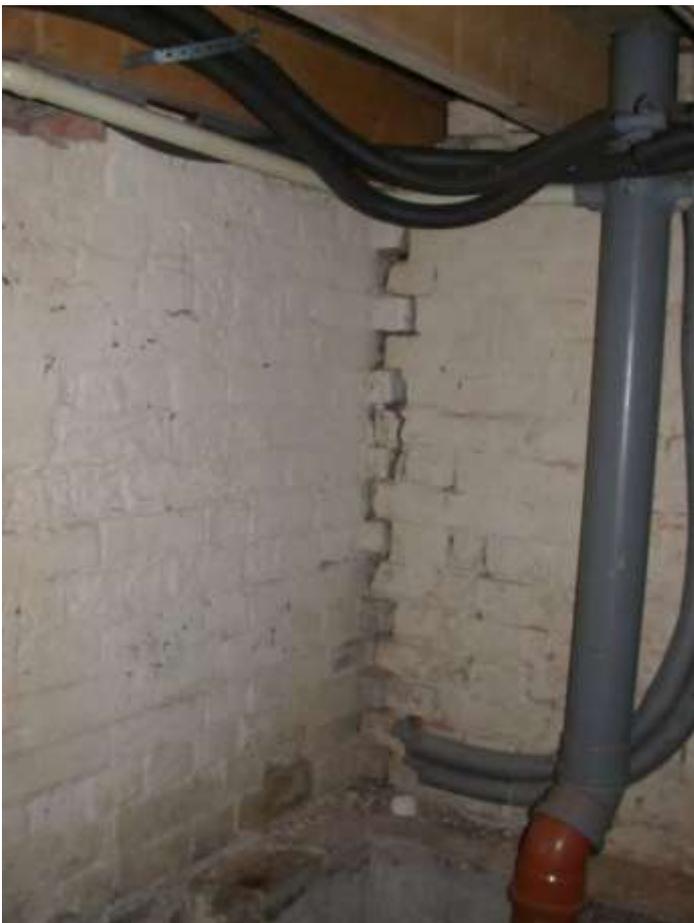
Fig. 64 left: In the ground floor area of the former maltings there is some separation of the brick courses at the north-west corner. Although this looks dramatic it is relatively easily to remedy although the cause will have to be investigated to ensure that the problem is not ongoing. It is worth pointing out that there is much paint inside the detached courses which does at least suggest it has been like this for some time with no further dramatic effect.

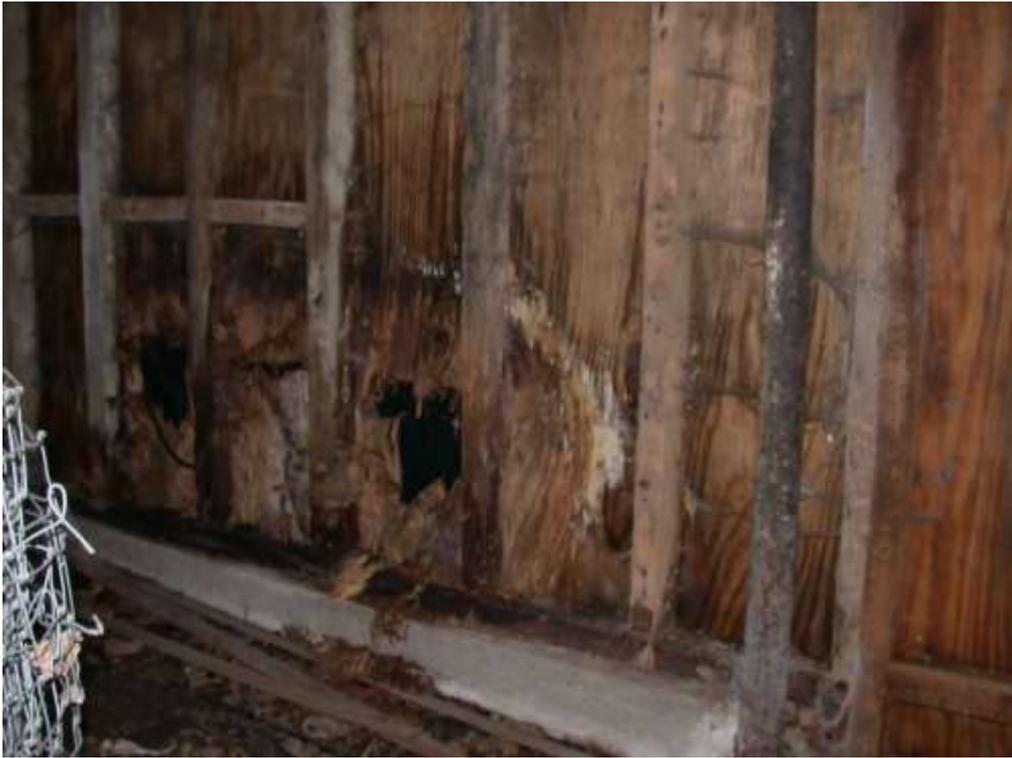
Fig. 65 above: Although this is merely plywood infilling to the north gable it does illustrate very well the effects of high moisture levels in timber, even engineered timbers such as plywood. Fungal decay has set in and is causing much degradation to the plywood. Even some small sections of softwood laid on the floor nearby had large blooms of fungal growth forming on them.
