Method Statement for the repairs at Curson Lodge, 47 St. Nicholas Street, Ipswich, Suffolk.

Number 47 St. Nicholas Street is a grade II\* listed building of the later 15<sup>th</sup> century. On 12<sup>th</sup> February 2013 a car crashed into the front entrance of the building and dislodged the carved corner post as well as badly damaging the pair of oak entrance doors.

Rick Lewis, Traditional Oak Carpentry Ltd. 22<sup>nd</sup> February 2013. Revised and updated 27<sup>th</sup> February 2013.

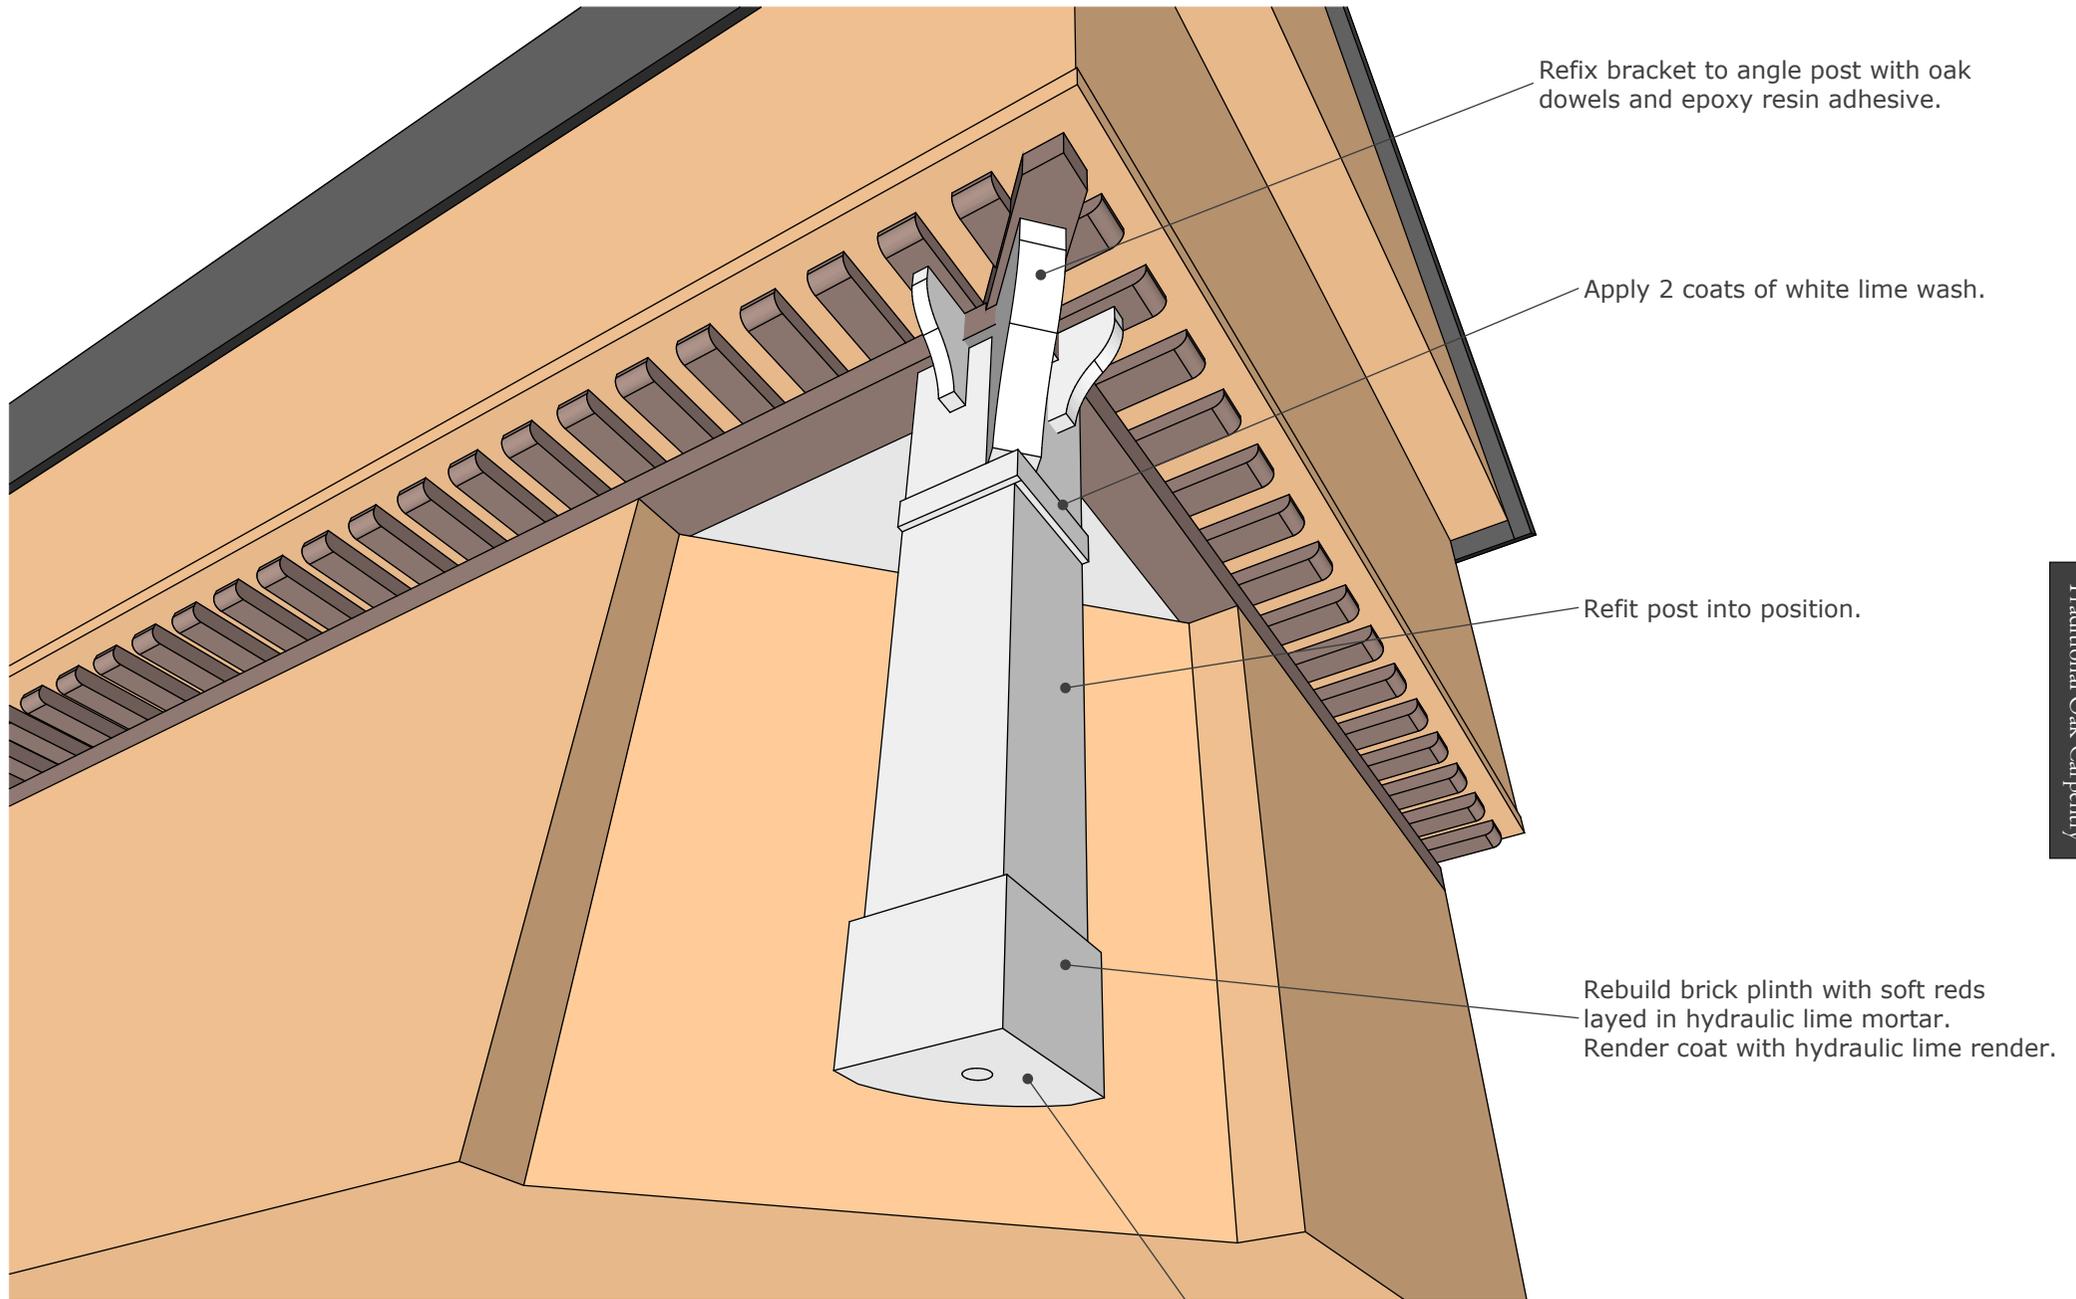
10mm Thk Plate welded to top of tube and screwed into underside of Dragon Beam.

MS Tube DIA 114 x 6.3mm Thk

Min 200mm cast in concrete below pavement level

Reinstate broken boxing with new dry oak planking.
