Anonymous Farmhouse, Middle-of-Nowhere, Suffolk.

A condition report on the historic carpentry.

I visited the property on 26th February 2013 to assess the condition of the historic timberwork prior to potential purchase.

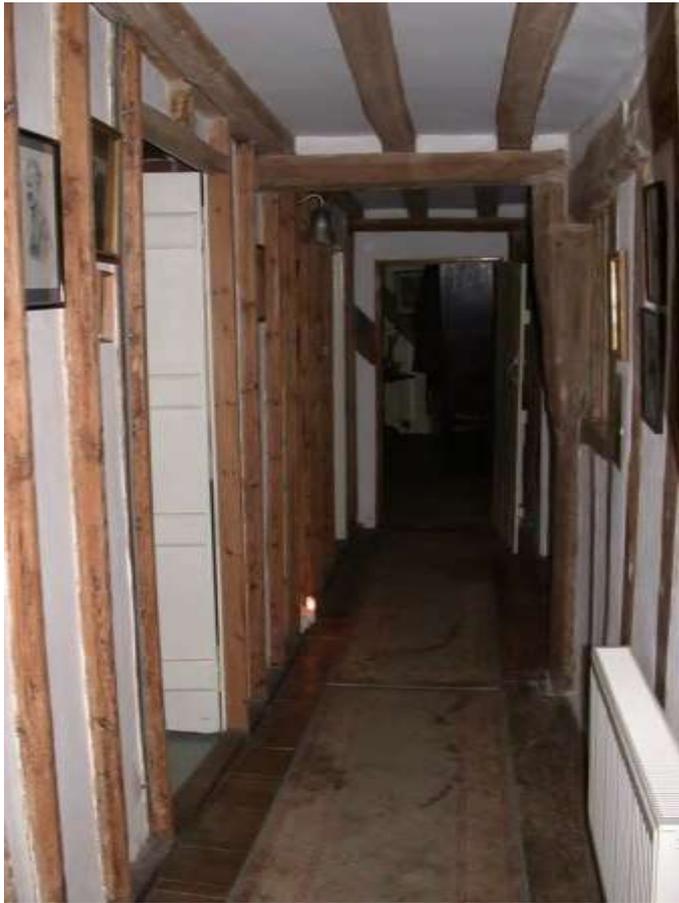
Fig. 8 left: The first floor rooms are all accessed via a corridor that runs north to south along the building. At one end is the 17th century spiral staircase which also runs up into the attic level. The corridor is formed by a simple stud wall that has probably been inserted during the 19th century when the brick facades were added. The stair is also adjacent to bedroom 4 which is in the south-west corner of the frame.

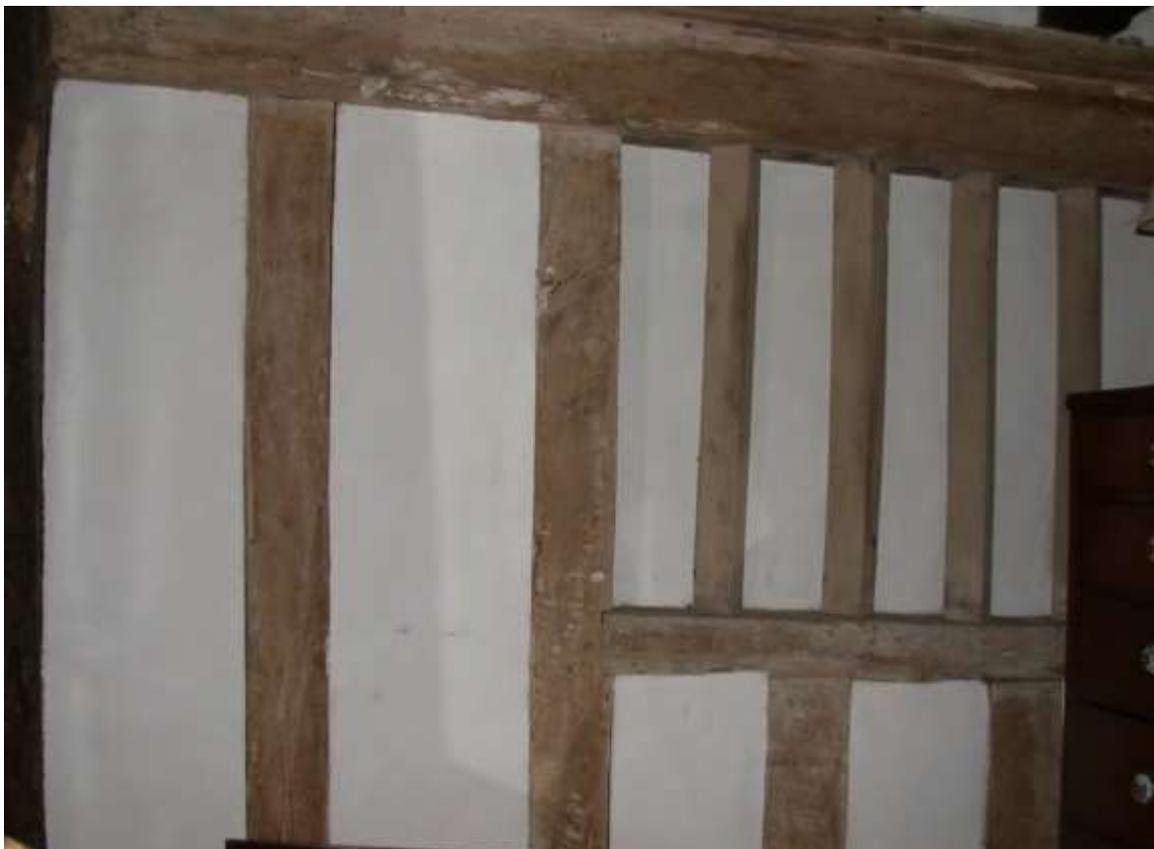
Fig. 9 below left: Bedroom 4 retains its framed walls on the east side although on the west side only the wall plate remains. The eastern framing has a diamond mullioned window although the mullions themselves are modern insertions.

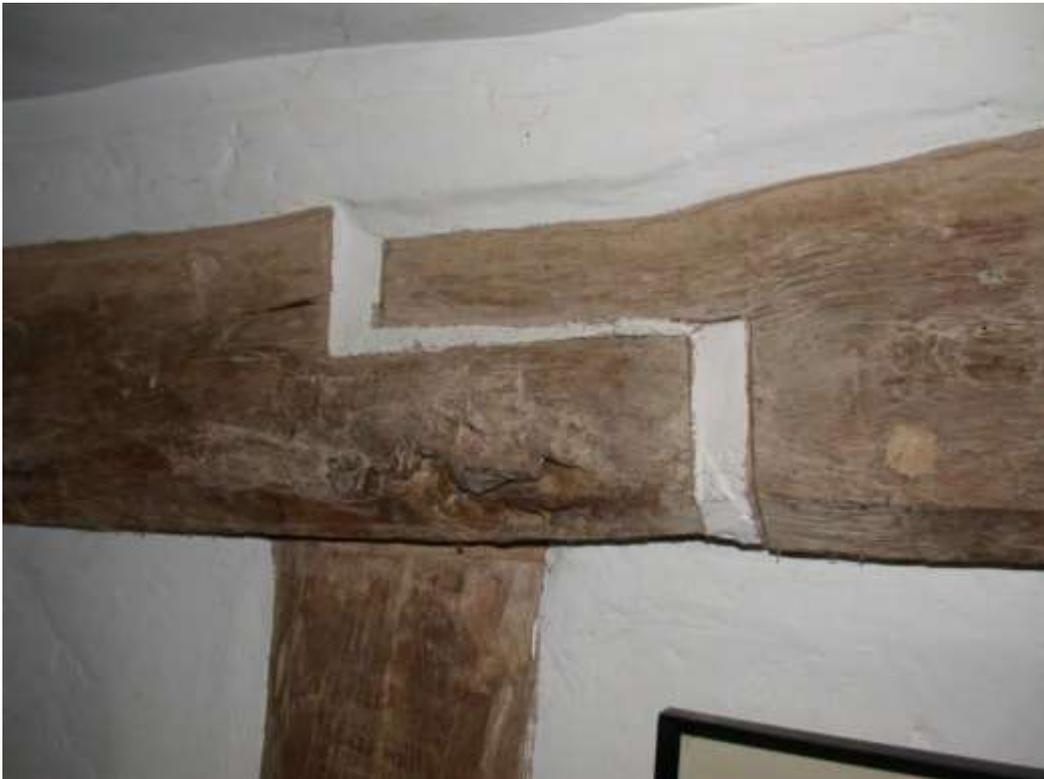
Fig. 15 below: Edge halved and bridled scarf joint to the eastern run of wall plate, typical of the 16th cent.

Moving north along the corridor the framing of the eastern wall is largely intact. It contains two good original windows complete with diamond mullions. The framing appears in very sound condition and although a brace has been removed half way along everything seems to be exactly where it should be.

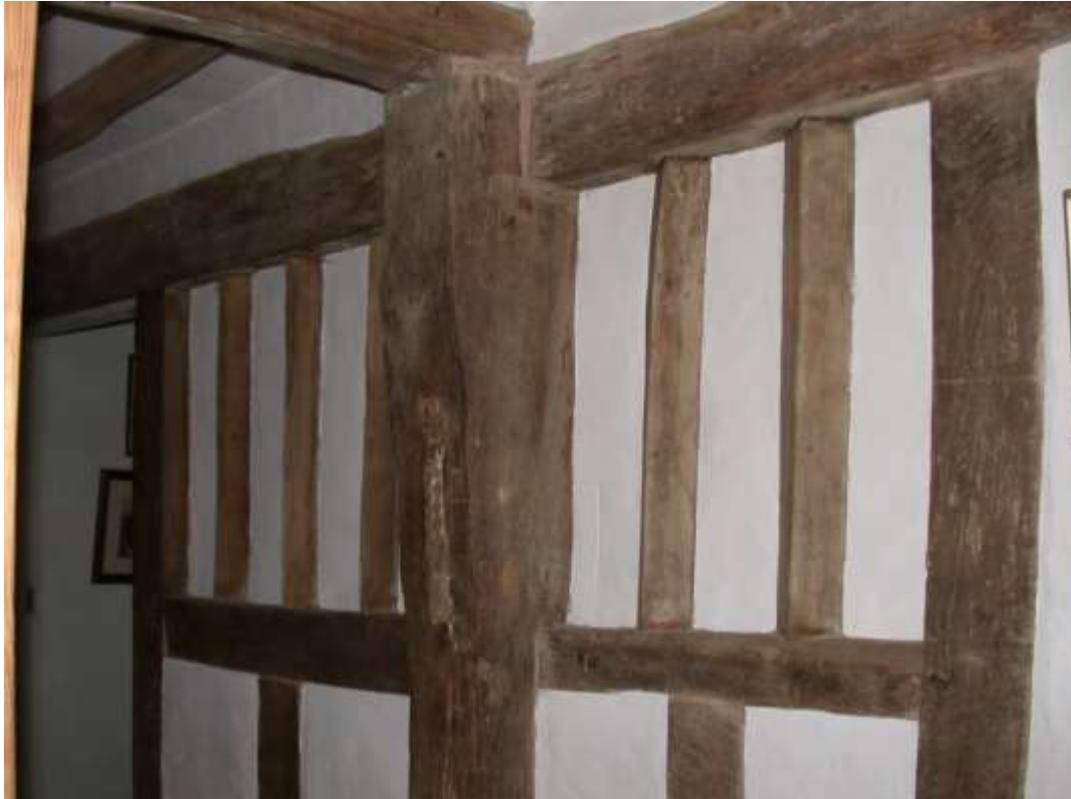
Fig. 16 above: Diamond mullion windows in the east wall. These windows are above the central 16th century hall space and prove that the frame was floored from the outset which would suggest that the frame is post Reformation. In fact the mouldings to the tie beams and floor timbers would suggest a date towards the end of the 16th century. The jowl post originally had a brace from just above sill level that jointed into the underside of the tie beam. This has been removed, no doubt when the corridor was inserted in the 19th century.

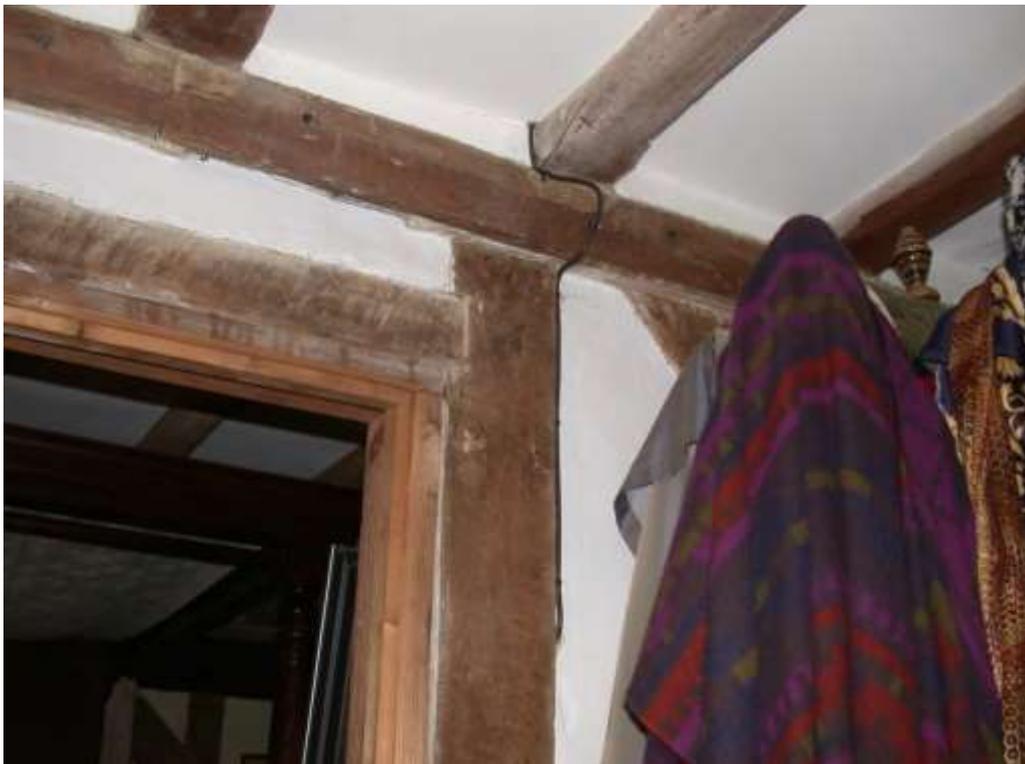
Fig. 21 below: Within bedroom 2/dressing room to bedroom 1. This partition is a mix of elm and oak and is in excellent condition. Much of it is original being the dividing wall between service chamber and hall chamber.

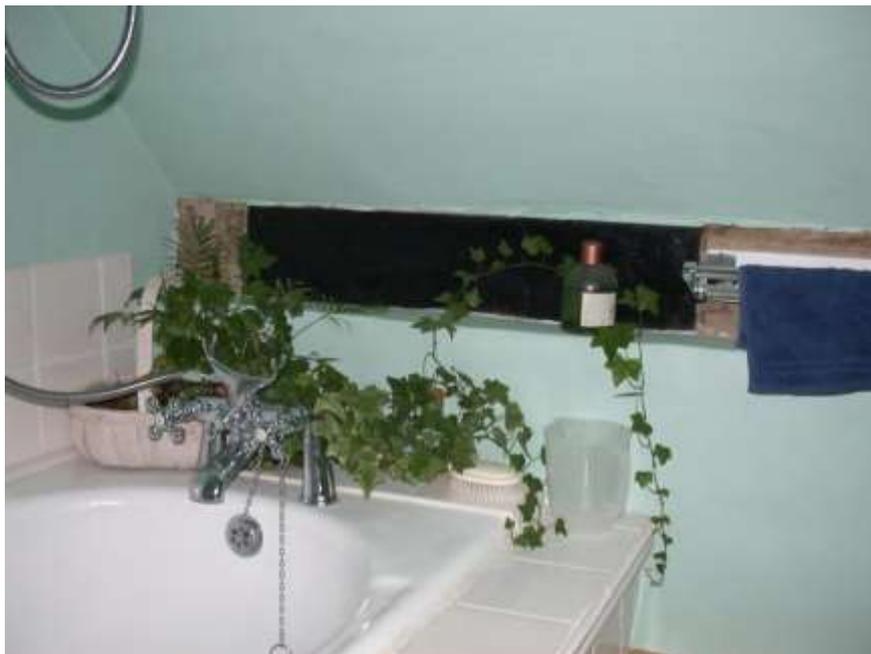
Fig. 22 above: the service wing has a steel bracket fixed between the end of the wall plate and the wall frame of the main house. It also has steel plating of similar provenance within the bathroom space (Fig. 23 below). I can ascertain no dire need for these and can only suggest they have been fitted by someone more cautious! Within the bathroom are over the wall plate scarfs (see later image) but from outside they seem superfluous.

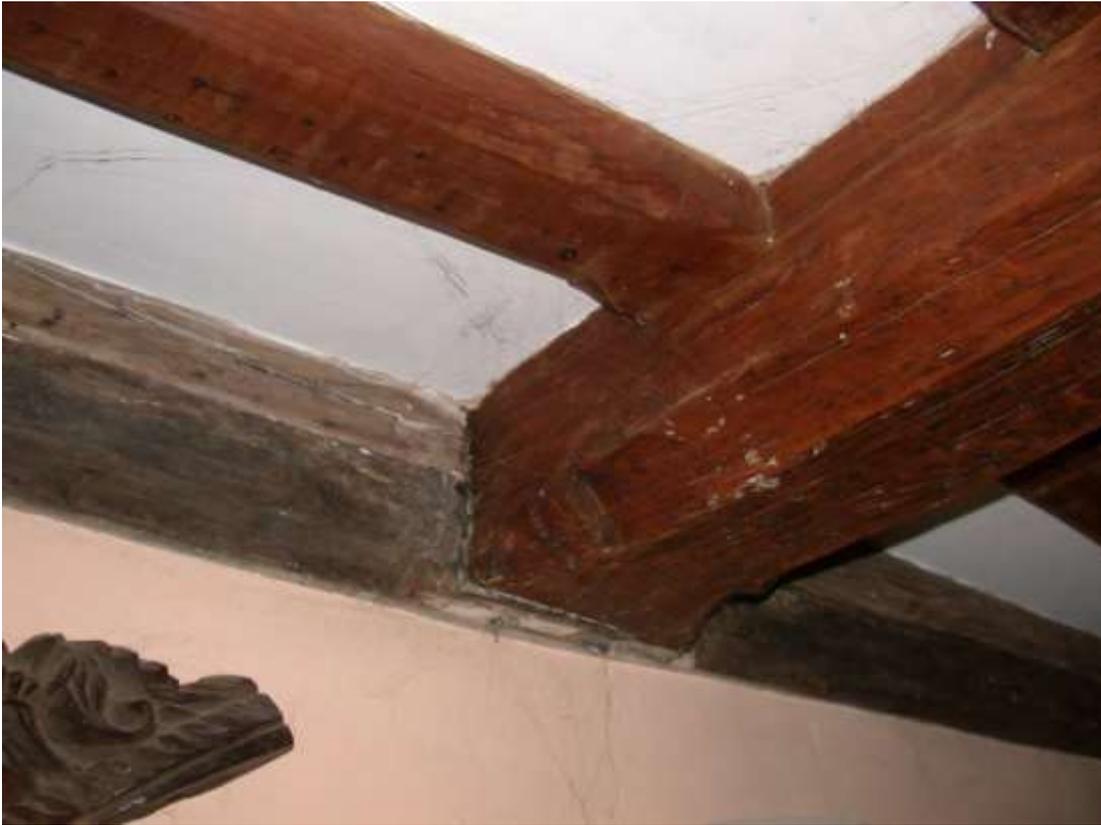
Fig. 24 above: Spine beam jointed into the rail above the chimney stack in the sitting room. The chamfer stops suggest a date from the later 16th century; note also that the joists have previously been plastered over evidenced by the lath nails in the common joist as well as the line in the stain where the ceiling once was.

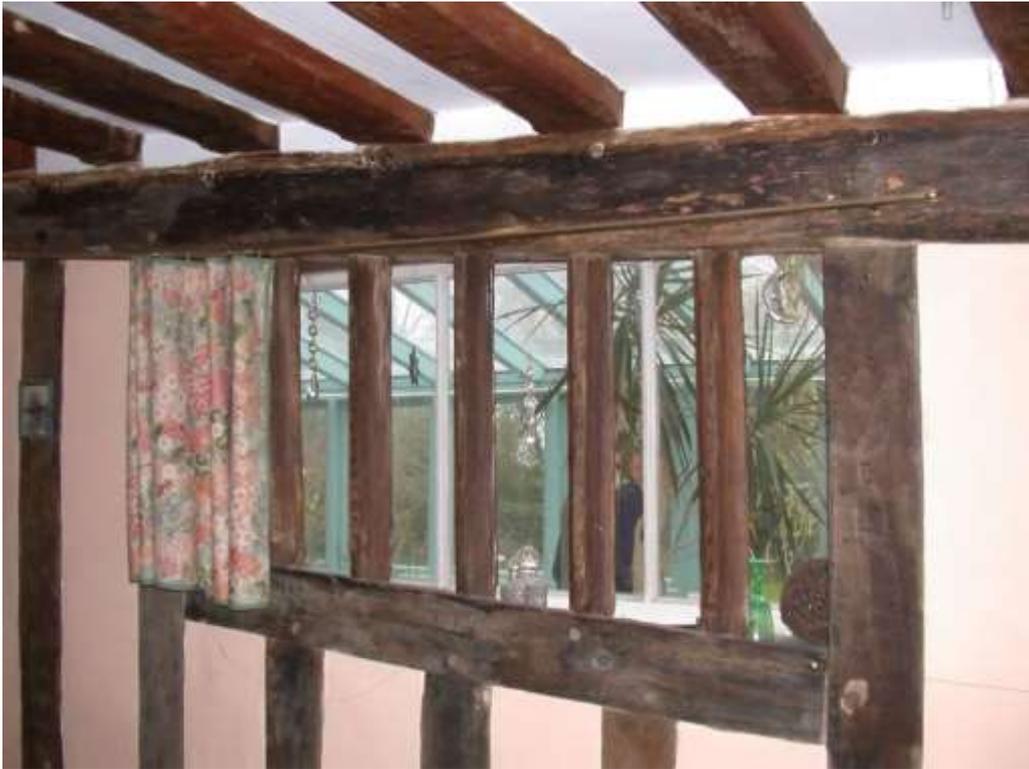
Fig. 26 above: Original mullioned window in the south east wall frame. This window is within the 16th century parlour chamber, the private family space of the occupants. It may have been glazed or at least contained a simple lattice (woven screen) or a fenestral (oiled cloth stretched on frames) along with shutters for security.

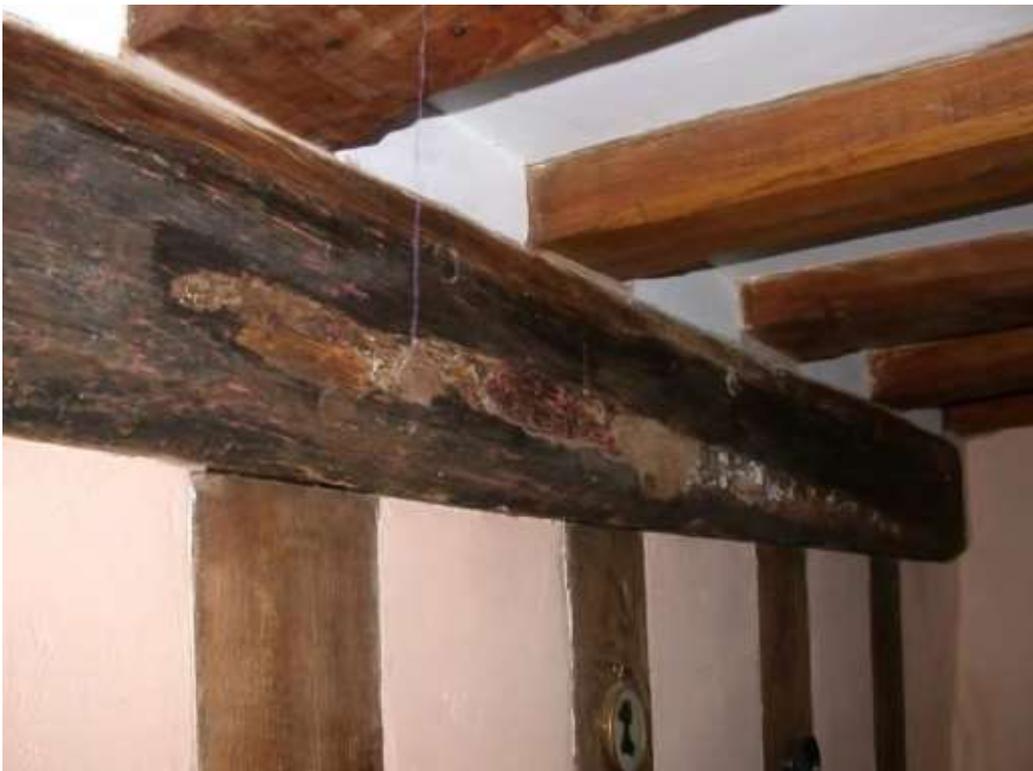
Fig. 27 below: The girding rail above the window has traces of an early red ochre paint scheme, probably 17th century or later as there are no traces on the joists; they had been lathed and ceiled over. Red was a very common colour scheme during the 17th century.

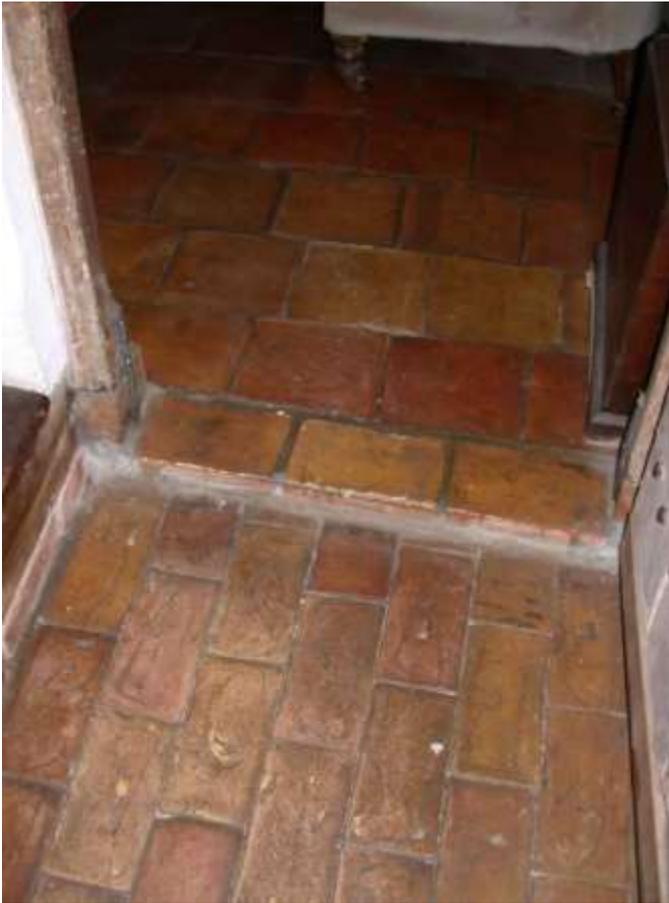
Fig. 28 left: Pamment and brick floors within the stairs lobby and the dining room appear largely undisturbed from their installation during the 19th century.

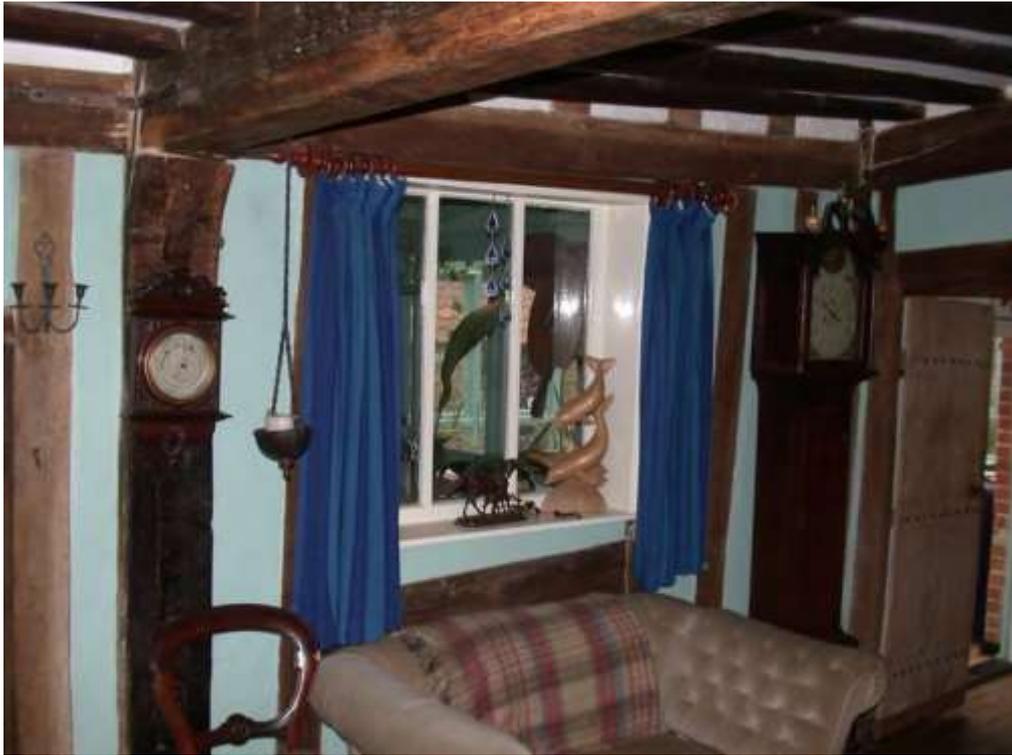
Fig. 30 above: Despite the Victorian refurbishment there are many original features still to be found within this building. The central storey post within what was the hall has remnants of fine moulding and evidence for a moulded shaft relief that has sadly been hacked off. The original hall oriel window sill still survives behind the sofa; the more recent window simply occupying the same space formed over 400 years ago. To the right of the clock is a chamfered door frame that would have led to the parlour in the original layout.

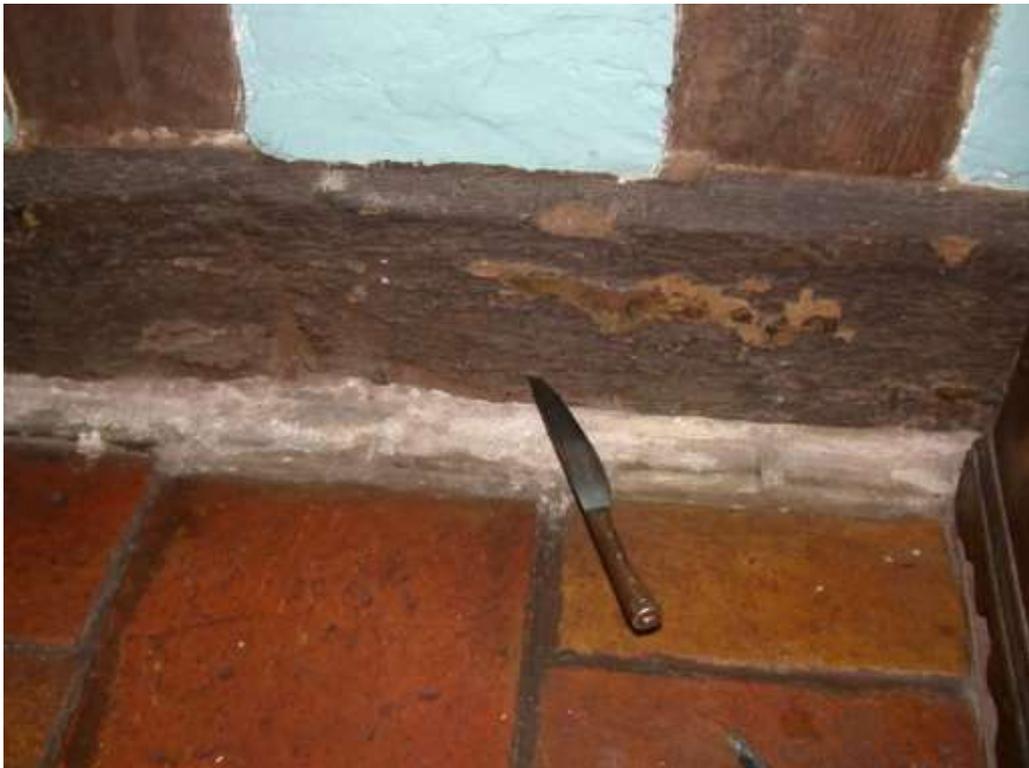
Fig. 31 below: The original 16th century sole plate is still in good order within the dining room.

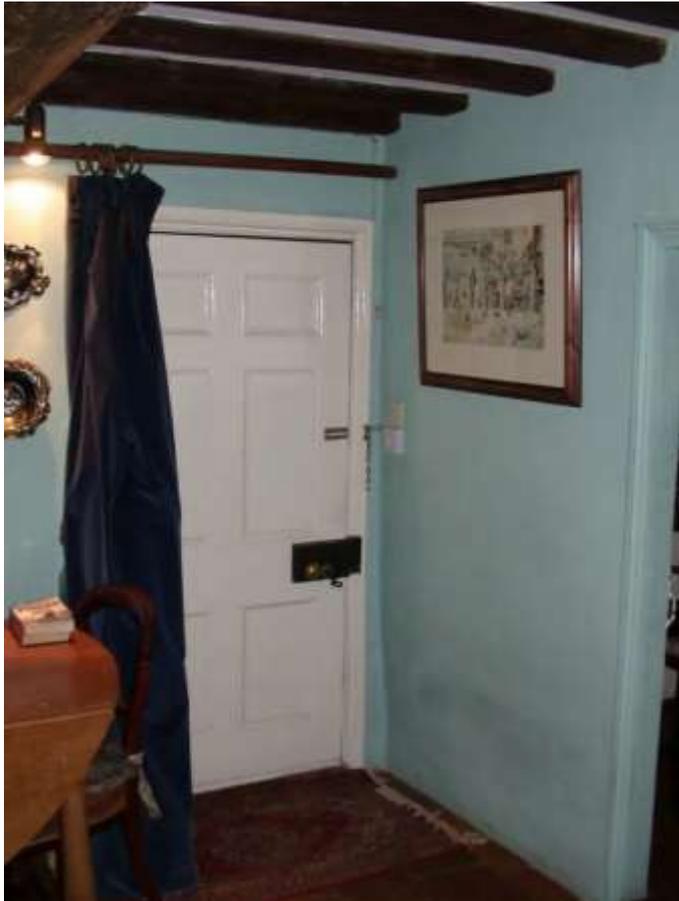
Fig. 32 left: The current front door enters the west wall of the dining room via a small brick porch. The 16th century front door would have been directly to the right in this picture, behind the wall which possibly still retains some of the screen from what was the cross-passage or screens-passage.

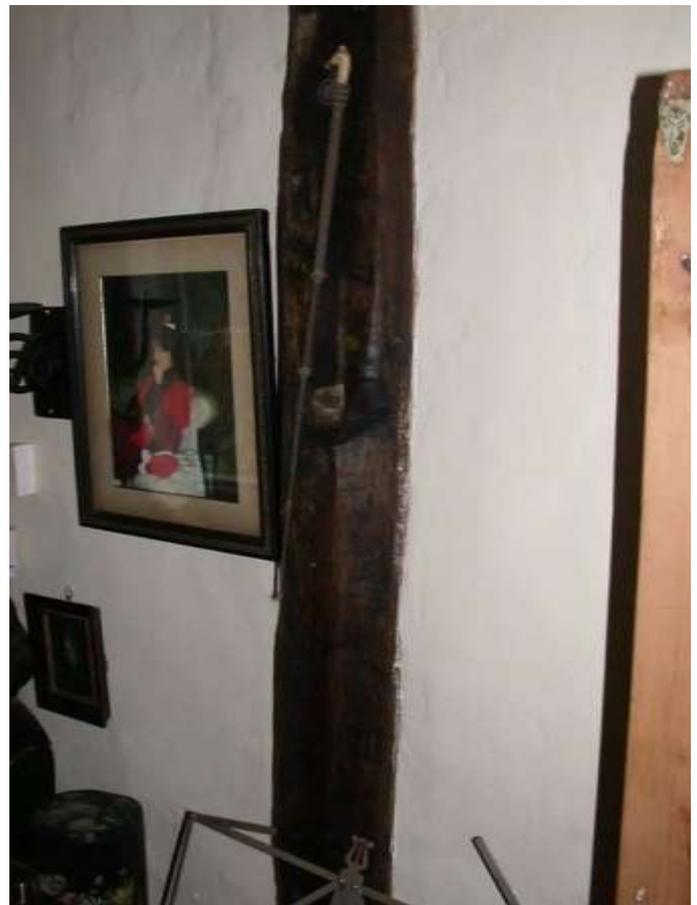
Fig. 32 right: Within the study the remains of one of the service end door frames can be seen. The cross-passage marked the space between the more public *hall* space and the functional service end of buttery and pantry. Two doors would have been within this space each entering a self-contained space for the storage of wet (buttery) and dry (pantry) foodstuffs.

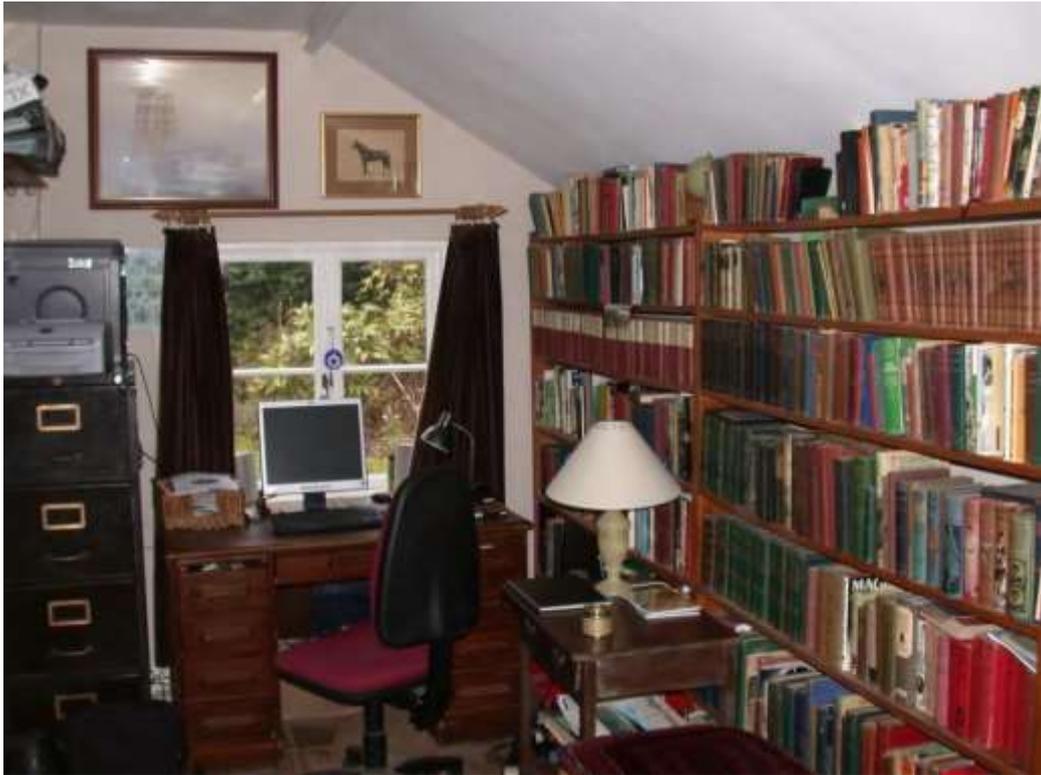
Fig. 33 above: The library is a relatively recent structure. It is built of brick and has no major carpentry visible.

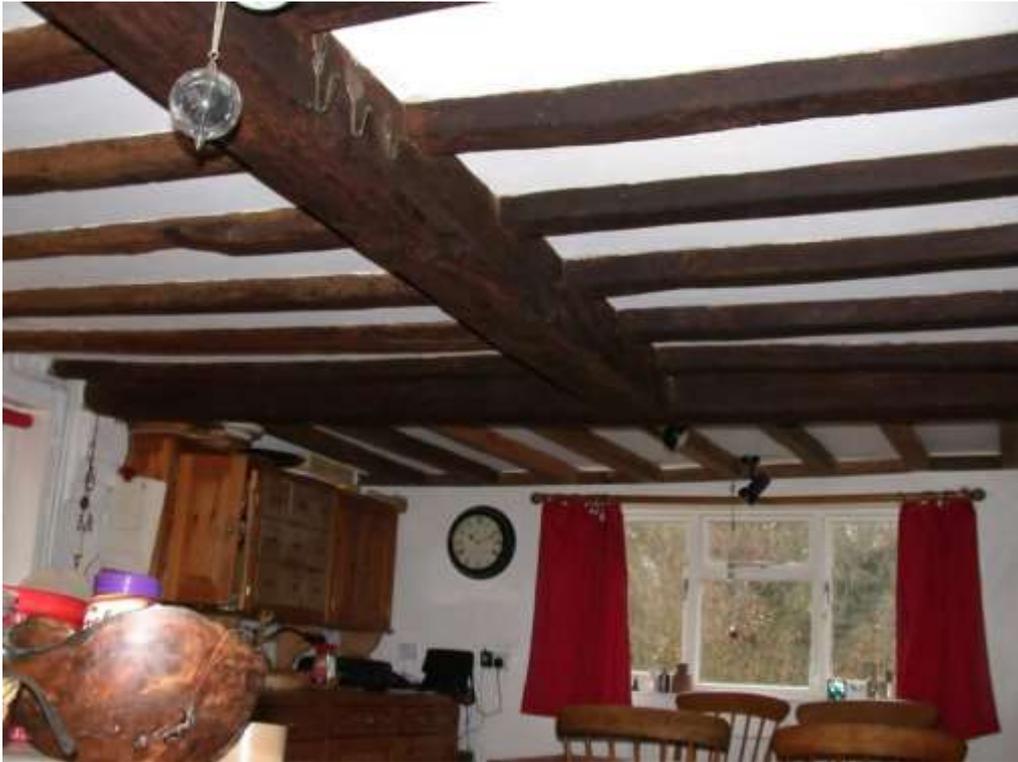
Fig. 35 above: The kitchen is a separately framed structure that was probably built in the early 17th century as a stand-alone kitchen wing. It partially blocks the cross-passage rear door and so may not have been built here until the cross-passage became redundant but it has also been heavily altered. It has an additional area of floor joisting that has been added, possibly within what was formerly a smoke bay. It has also been clad with brick, possibly at the same time as the front and rear as the rear façade stops *against* this wing on its south face.

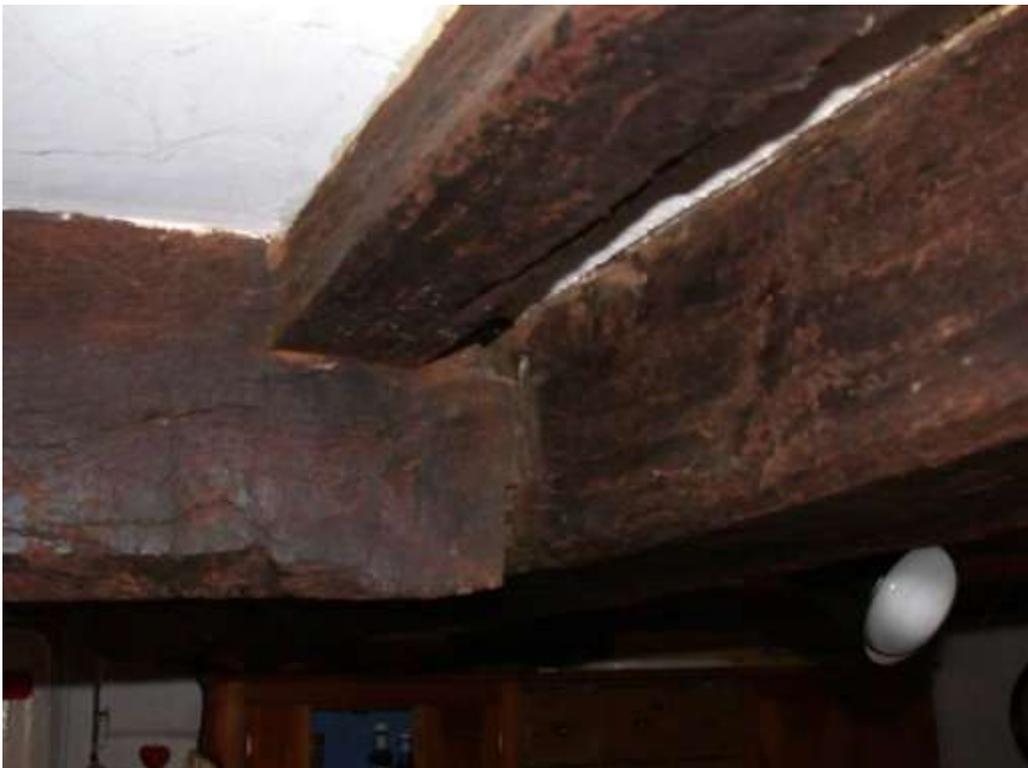
Fig. 36 below: Joisting within the kitchen wing is heavily sooted; this is quite common given its original use.

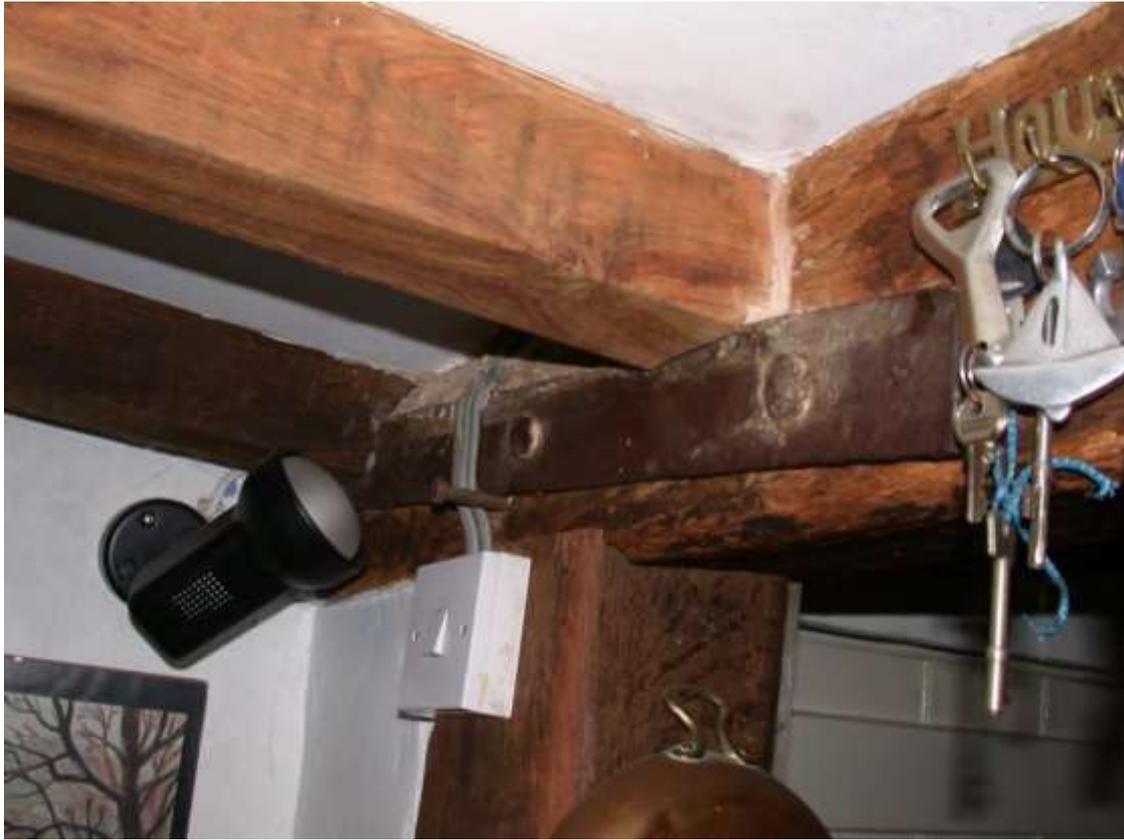
Fig. 37 above: Iron straps secure the floor rail into the brick walls. It is possible that the frame was brought here during the 19th century and assembled from a late 16th/early 17th century kitchen wing with other alterations to form the present building.

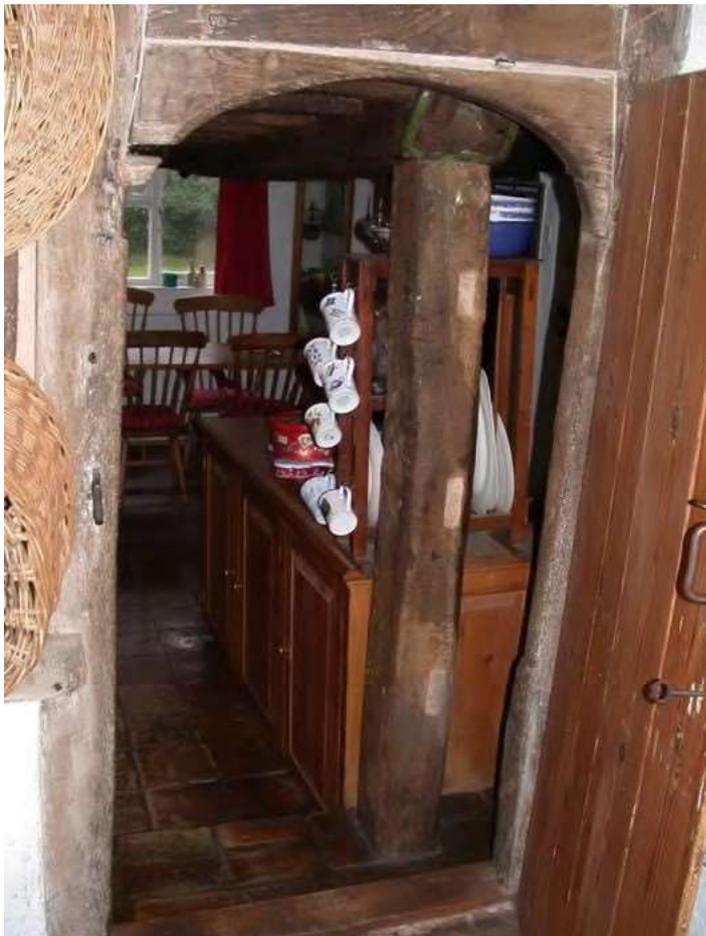
Fig. 38 left: Whenever the kitchen wing was built here it seems likely that the cross-passage had become redundant. The cross-passage was a plan form that had been in use since the medieval period but during the 17th century most are replaced by the lobby-entry plan. The position of this supporting post, formed from a re-used timber, would not permit normal use of the passage.

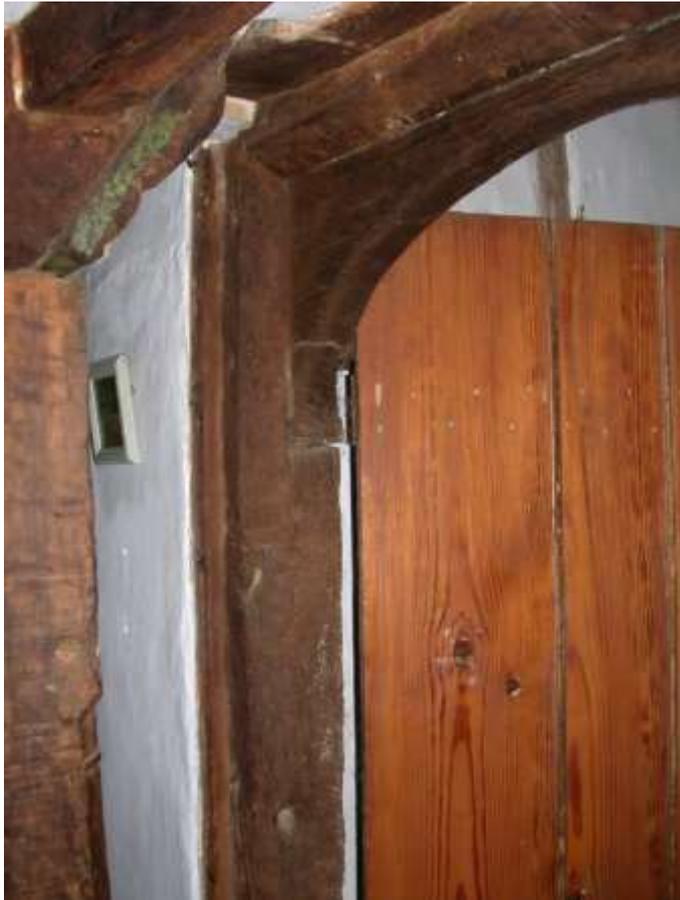
Fig.39 left: An almost complete survival of the rear door. It has a four-centred arched head and the surrounding frame is heavily chamfered.

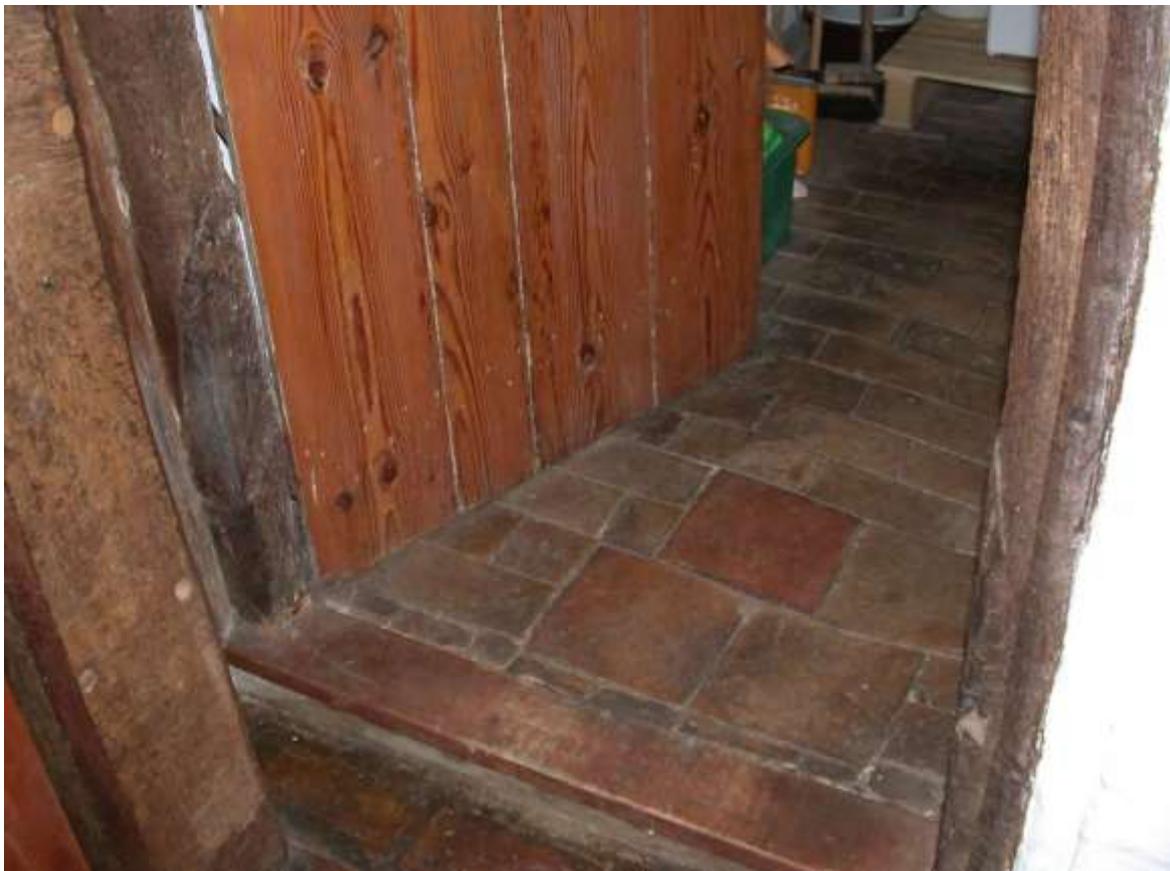
Fig. 40 below: Care and repair. The brick floor within the old service end has many undulations formed by heavy foot traffic over time. It has been carefully repaired with pammments and the whole floor seems largely untouched from the time it was first laid. Many such floors have been raised and re-laid over concrete to the detriment of surrounding timber fabric.

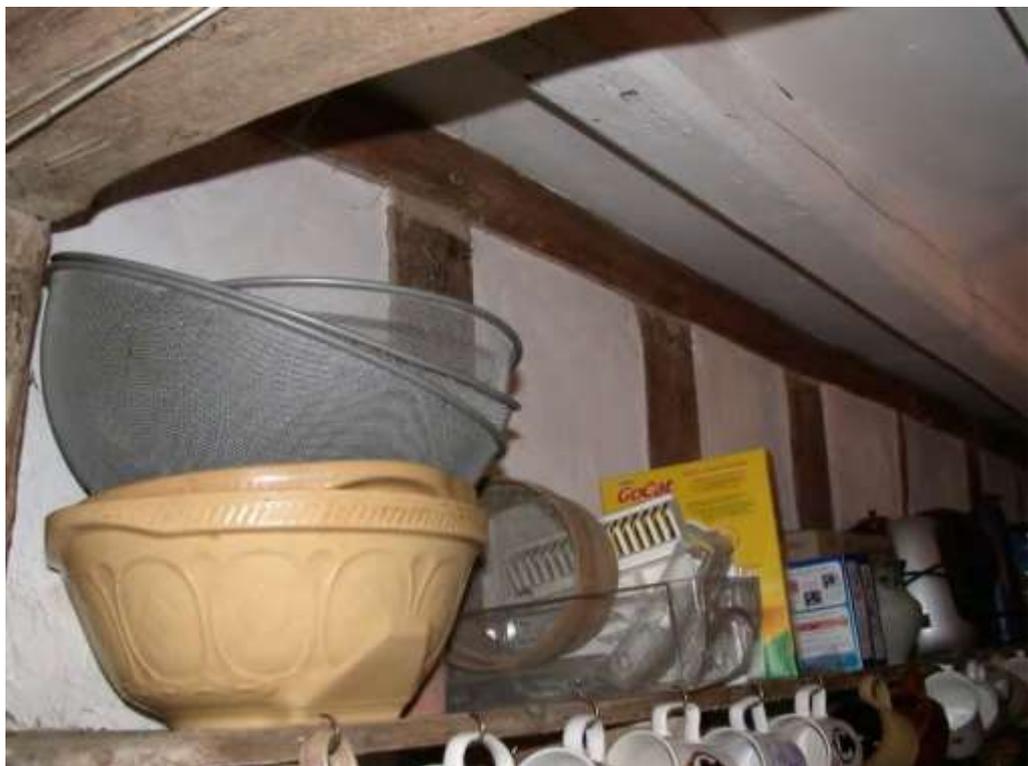
Fig. 42 below: The list description states that the service partition has been lost but quite clearly it has not. Many list descriptions are inaccurate and this is a good example I'm afraid. The studs below form the dividing wall between buttery and pantry and are clearly pegged into the joist above which suggests original fabric.

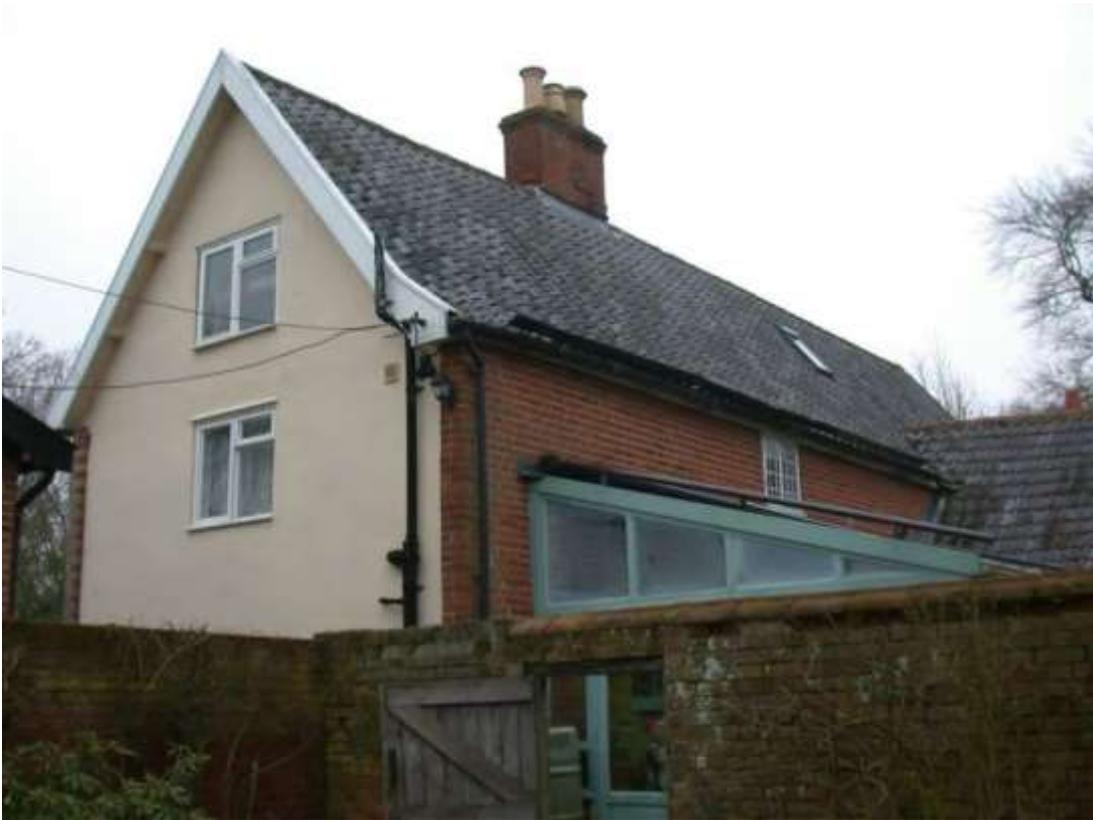
Fig. 43 above: Anonymous Farmhouse from the south east. Both brick facades can be seen to be separate with presumably the original framing largely surviving beneath. The black glazed pantiles are very typical of south Norfolk and the Waveney Valley region of north Suffolk.

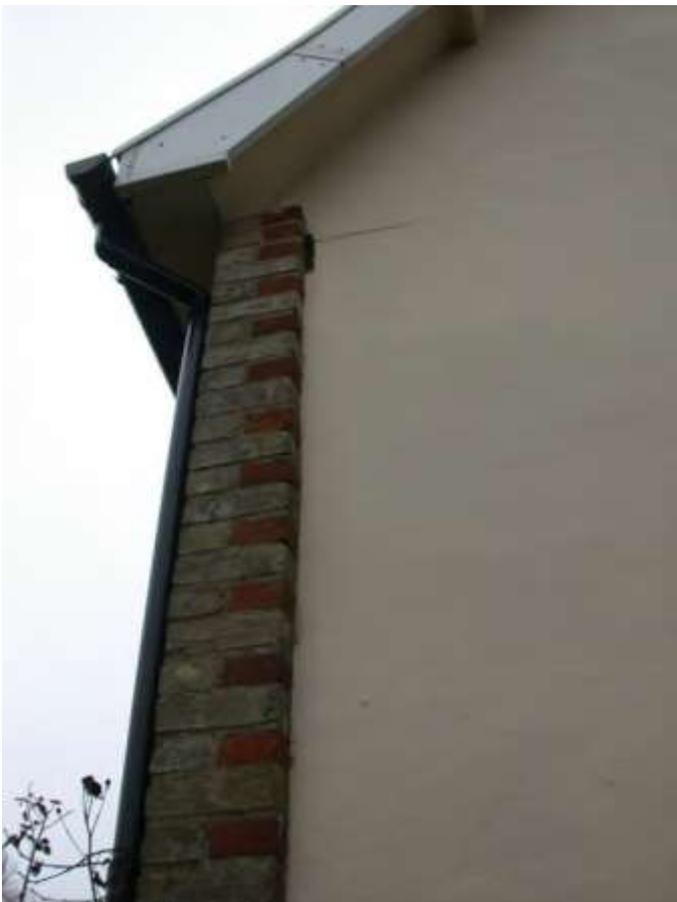
Fig. 44 left: the brick quoining of the front elevation with Woolpit whites and local soft reds. The white brick detailing would have cost more and has only been used on the front elevation for economy. The render between the two facades seems to be cement based but is in reasonable condition.

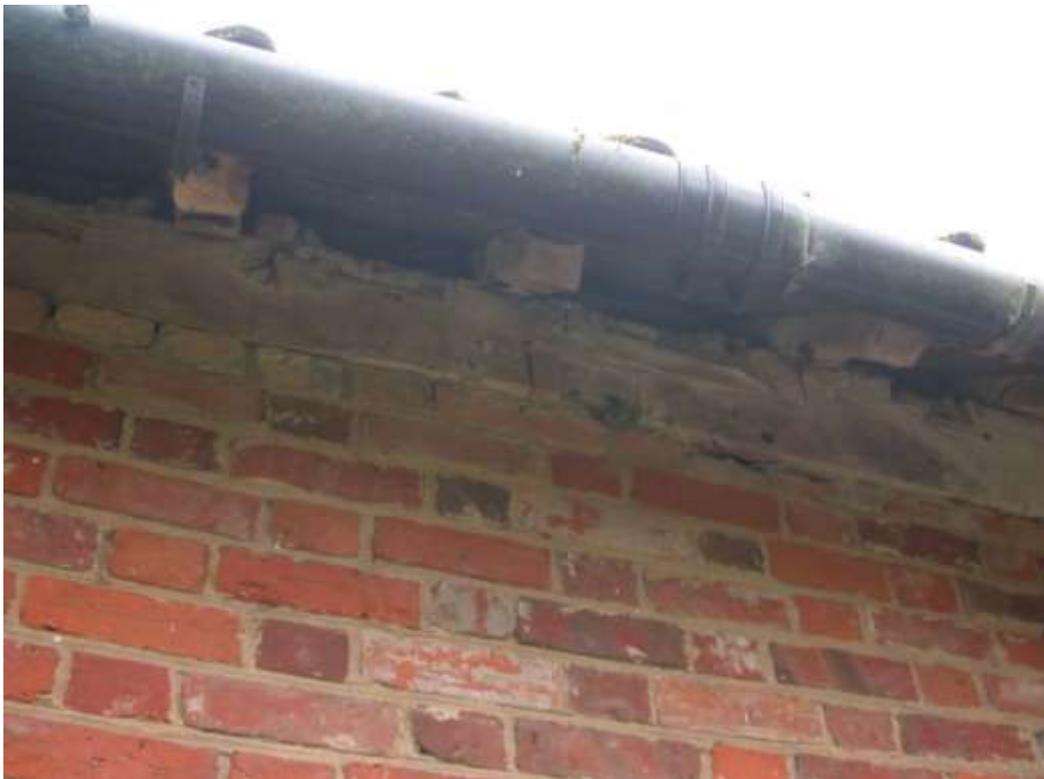
Fig. 48 below: Edge halved scarf joint in the wall plate of the kitchen wing. This joint tallies with the steel plates inside the bathroom yet they appear sound and in good order. Joint evidence suggests this is its second roof.

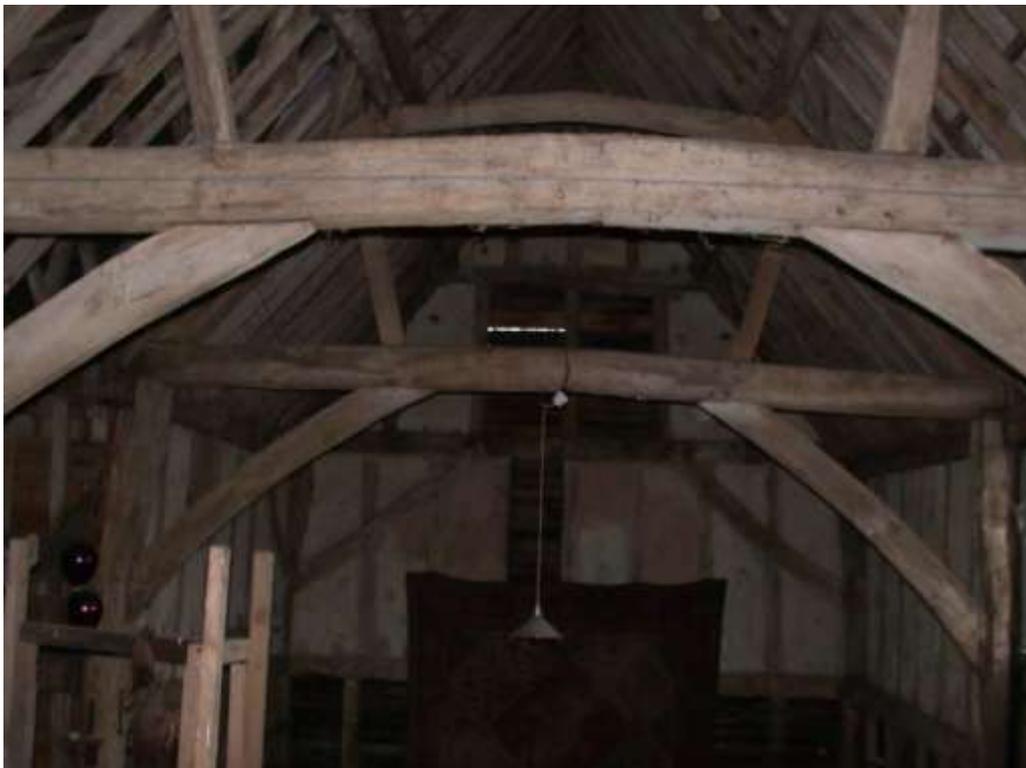
Fig. 52 below: Inside the barn looking east. The late 16th century barn frame is in excellent condition.
