Anonymous Farmhouse, Middle-of-Nowhere, Suffolk.

A condition report on the historic carpentry.

I visited the property on 26th February 2013 to assess the condition of the historic timberwork prior to potential purchase.

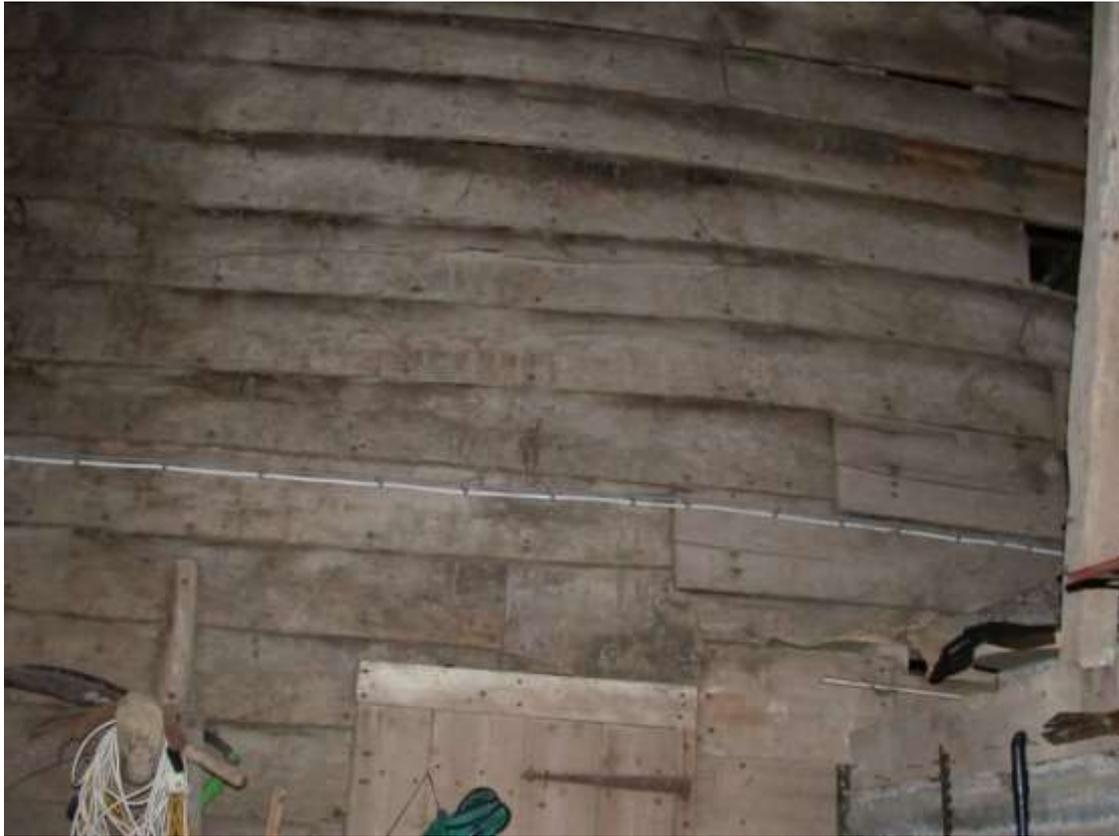
Fig. 53 above: Much of the barn has relatively intact early boarding. This should be preserved and maintained as much as possible.

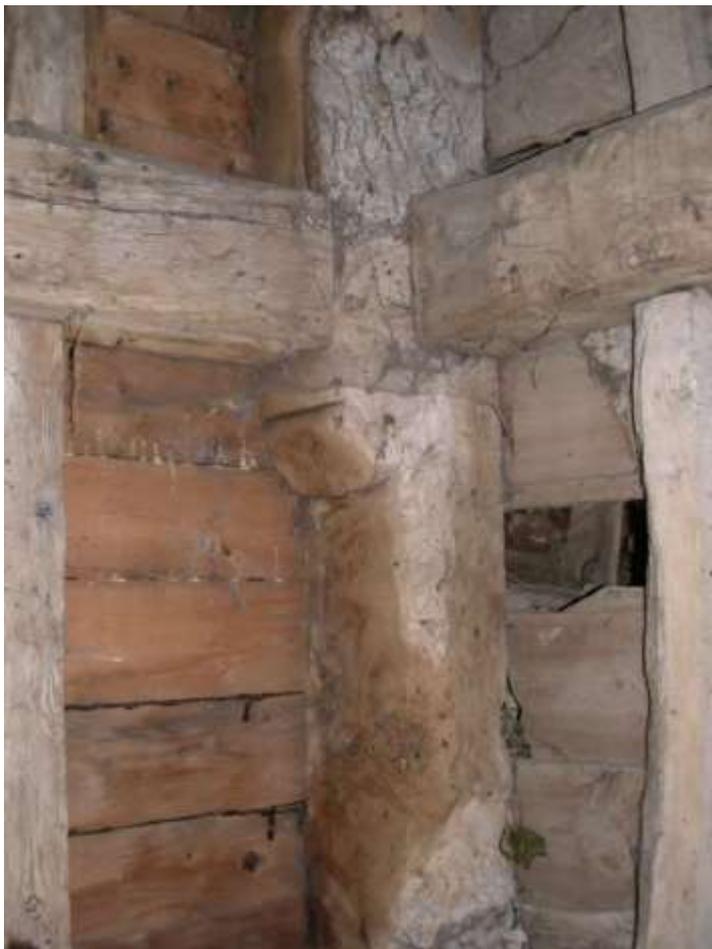
Fig. 54 left: The northern porch to the barn is of a later date, probably the 17th century. Note the decorative sections to the posts where the girding rails meet.

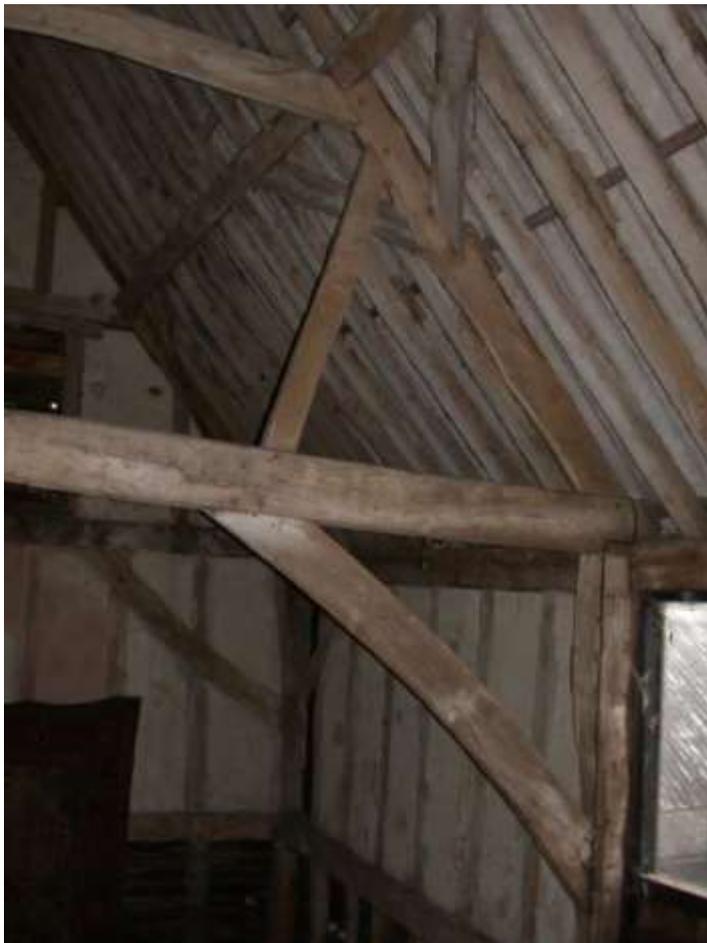
Fig. 56 left: The clapsed purlin roof with queen struts between tie beam and principal rafter is essentially the same design as the house. It appears to be in excellent order and has suffered no major loss or distress over time that I could see.

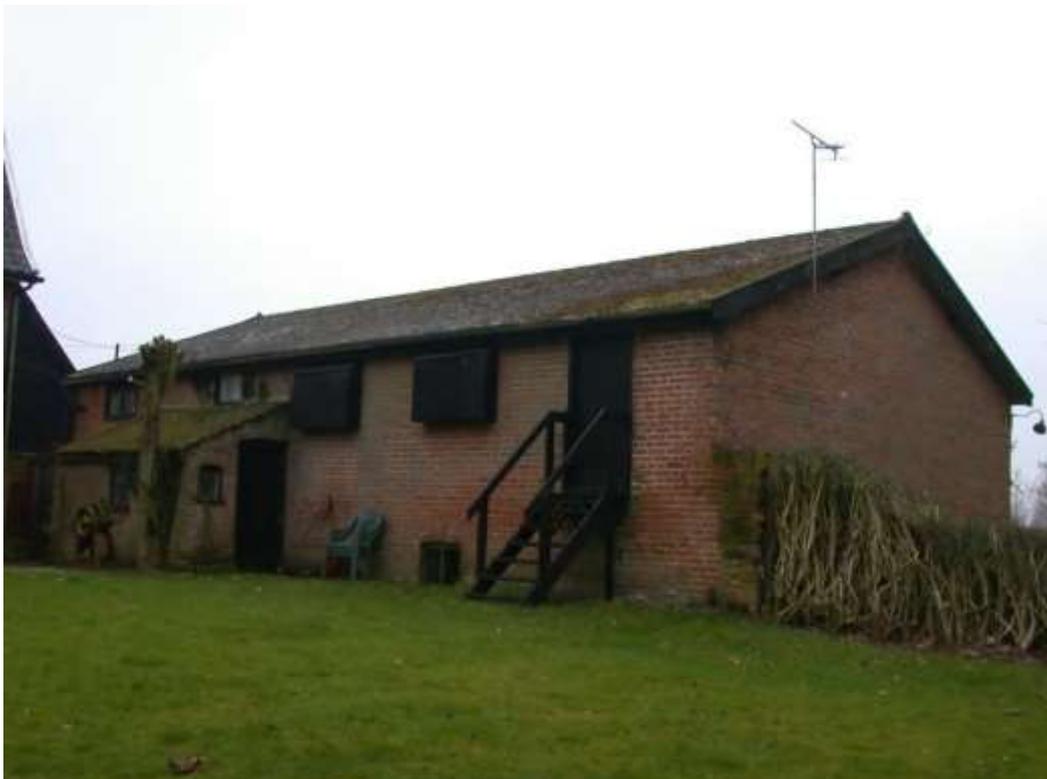
Fig. 58 below: The maltings from the north east.

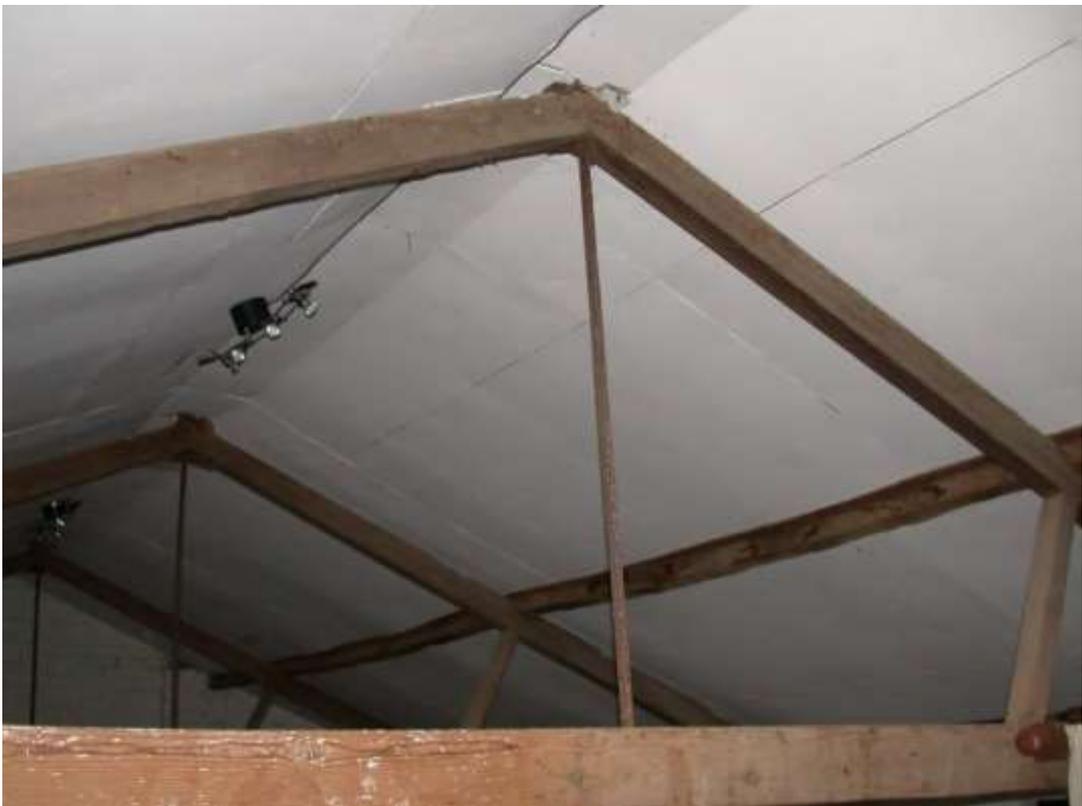
Fig. 60 below: The softwood trusses within the first floor area of the maltings have iron “king posts” supporting the long (imported colonial?) pine tie beams. Despite some light surface rust they seem in excellent order.

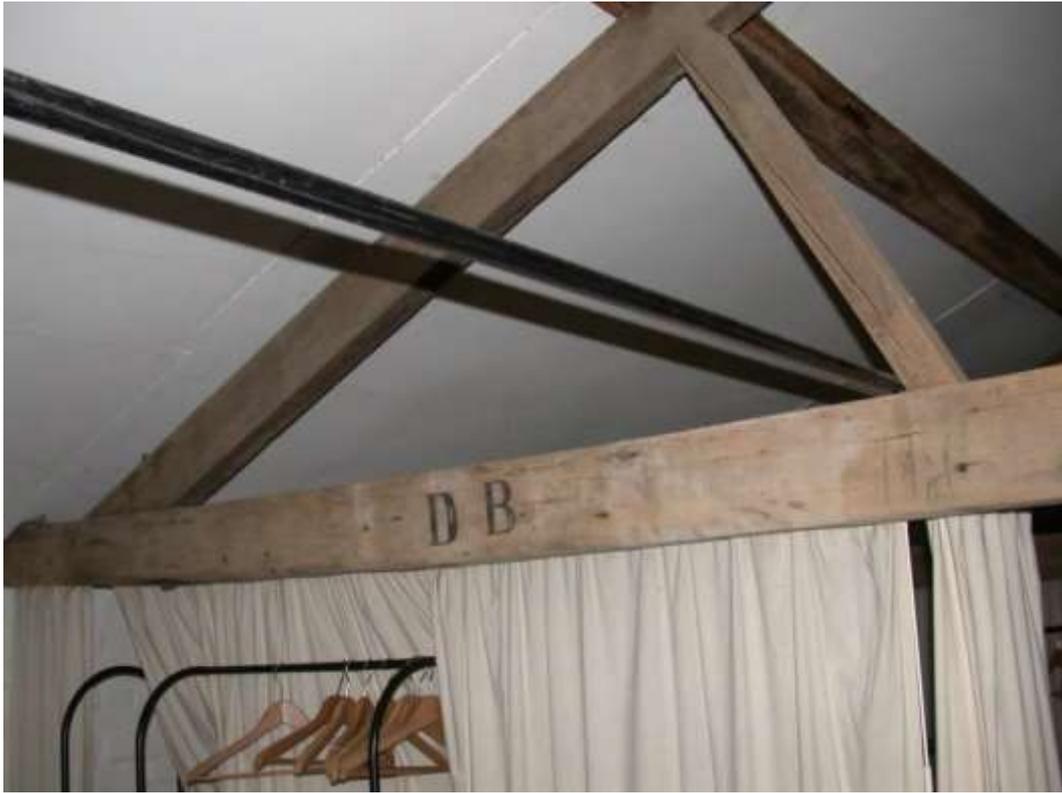
Fig. 61 above: The trusses contain some historical interest despite their relative newness and industrial design. Painted initials and (below, Fig. 62) race-knife markings all add interest to an otherwise utilitarian design.

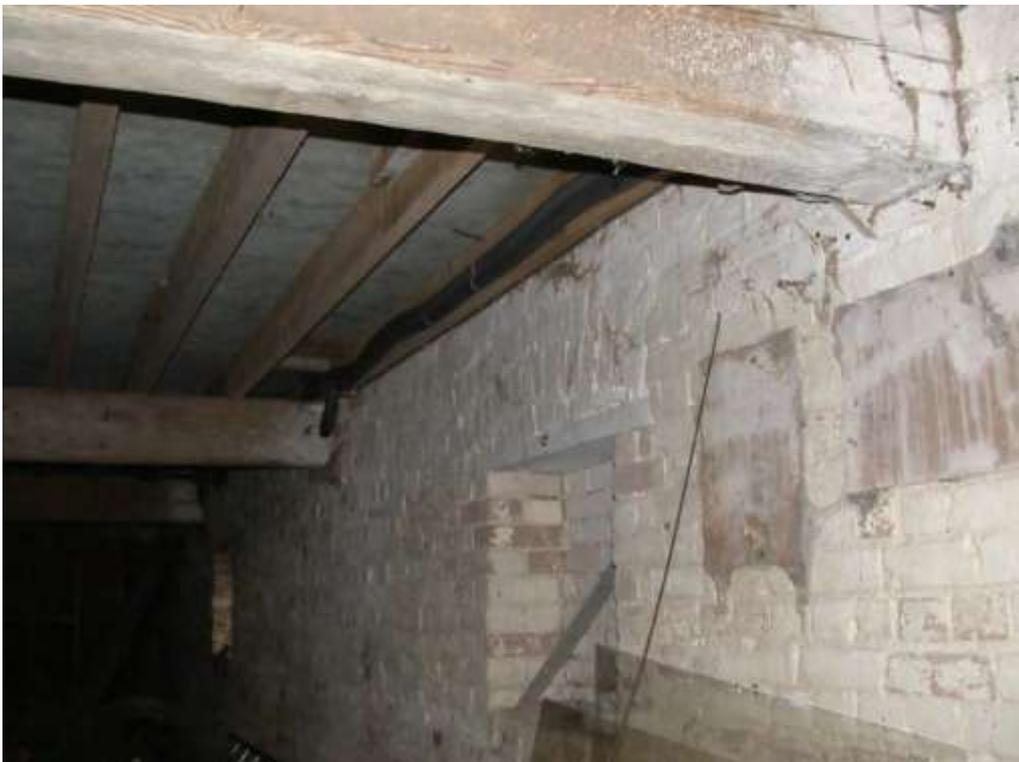
Fig. 66 below: Although these rails enter the masonry they appear sound at their ends. Given that they are softwood this is the crucial detail to maintain and so far they seem fine despite the nearby moisture levels.
